TEST REPORT #204690

VITA 46 CONNECTOR/MODULE QUALIFICATION TEST

To perform qualification testing of the VITA 46 Connector Set as manufactured and submitted by the test sponsor, Curtiss-Wright Controls Embedded Computing.

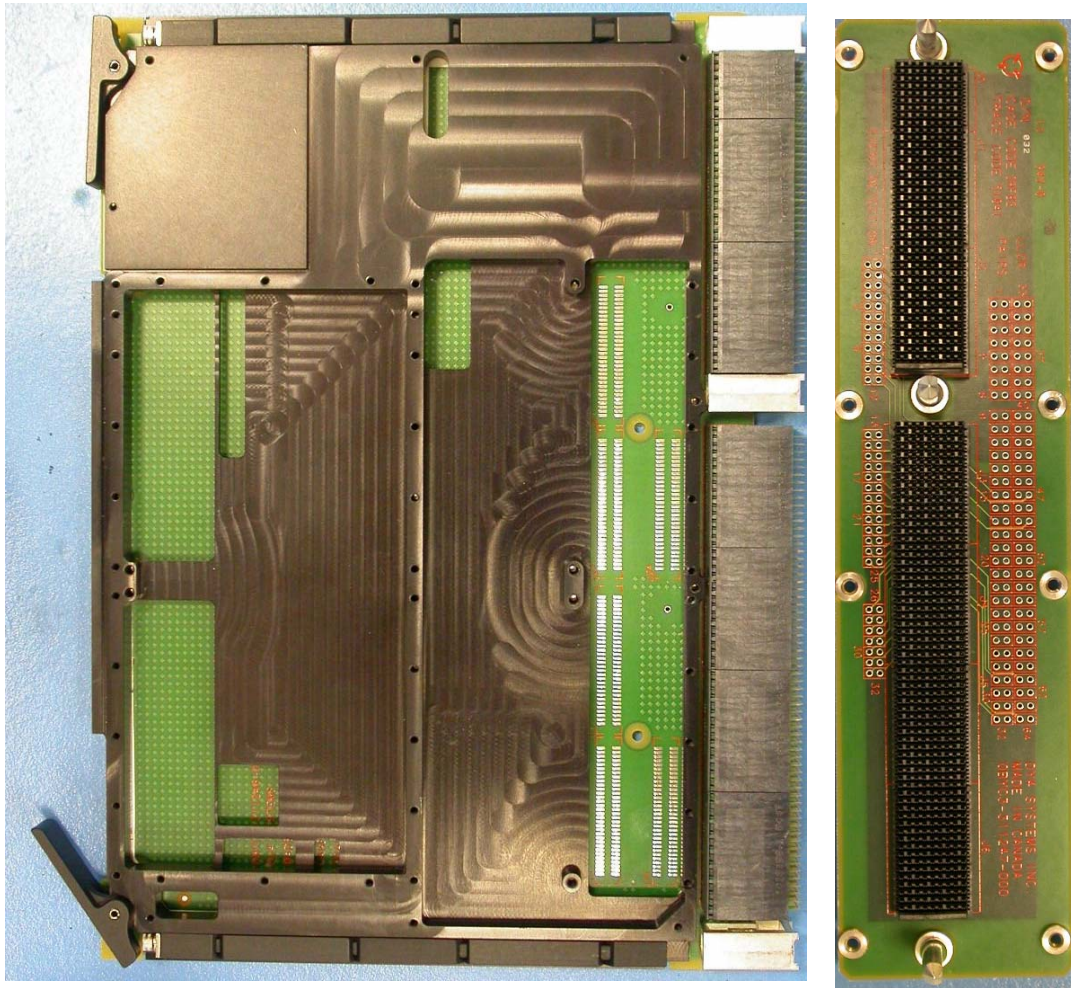
Fig. 1 VITA 46 Connector/Module Qualification Test Sample.

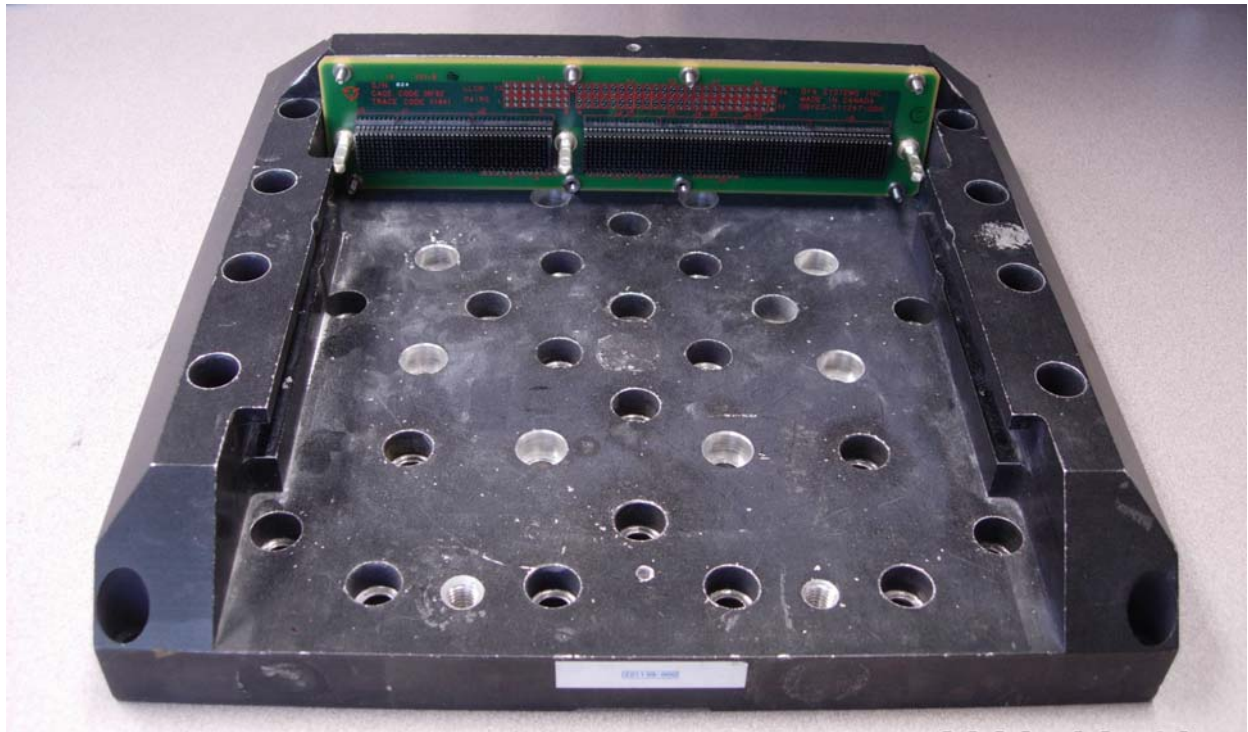
Fig. 2 Vibration fixture used for VITA 46 shock and vibration testing of conduction cooled test card in Fig. 1

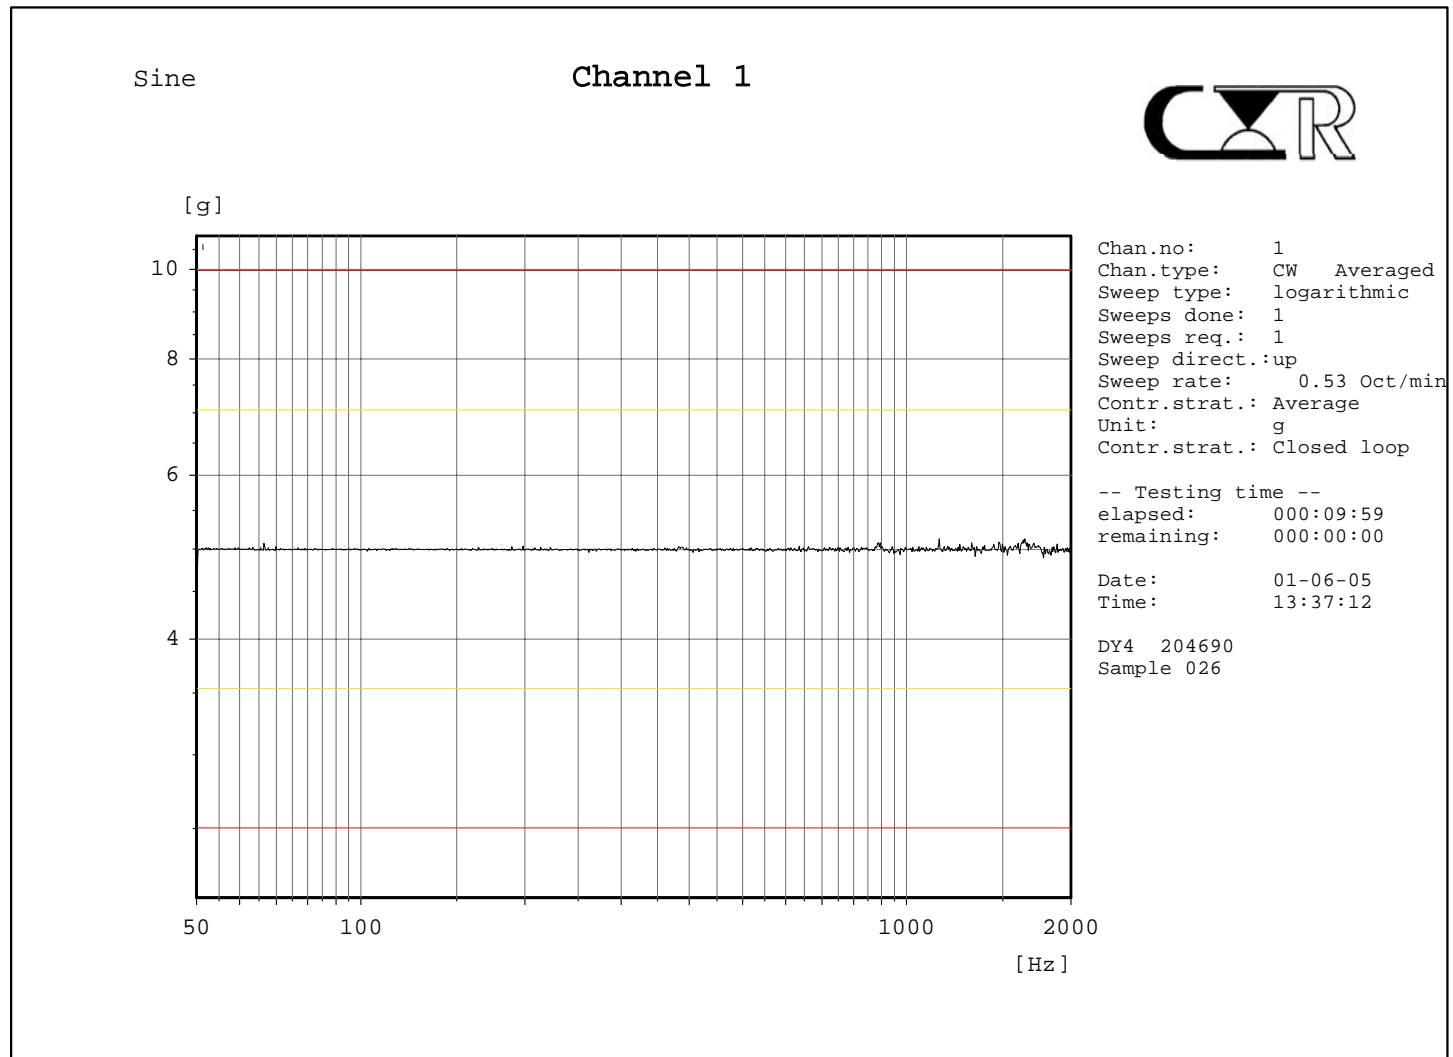
Fig. 3 Control accelerometer output (S/N 026, sine vibration)

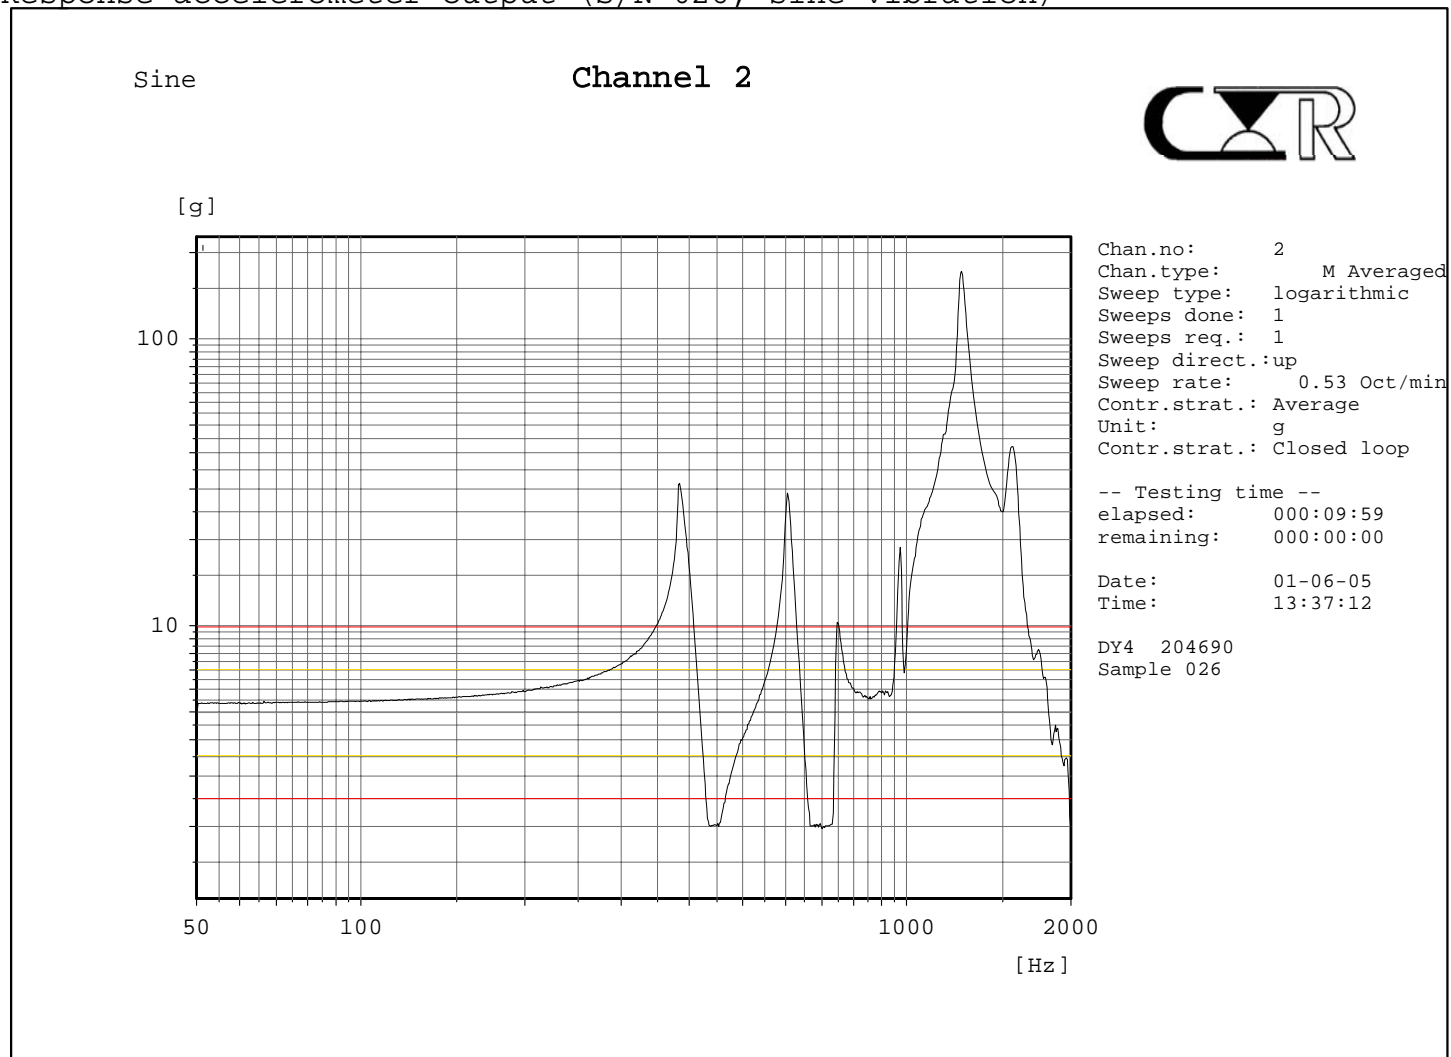
Fig. 4 Response accelerometer output (S/N 026, sine vibration)

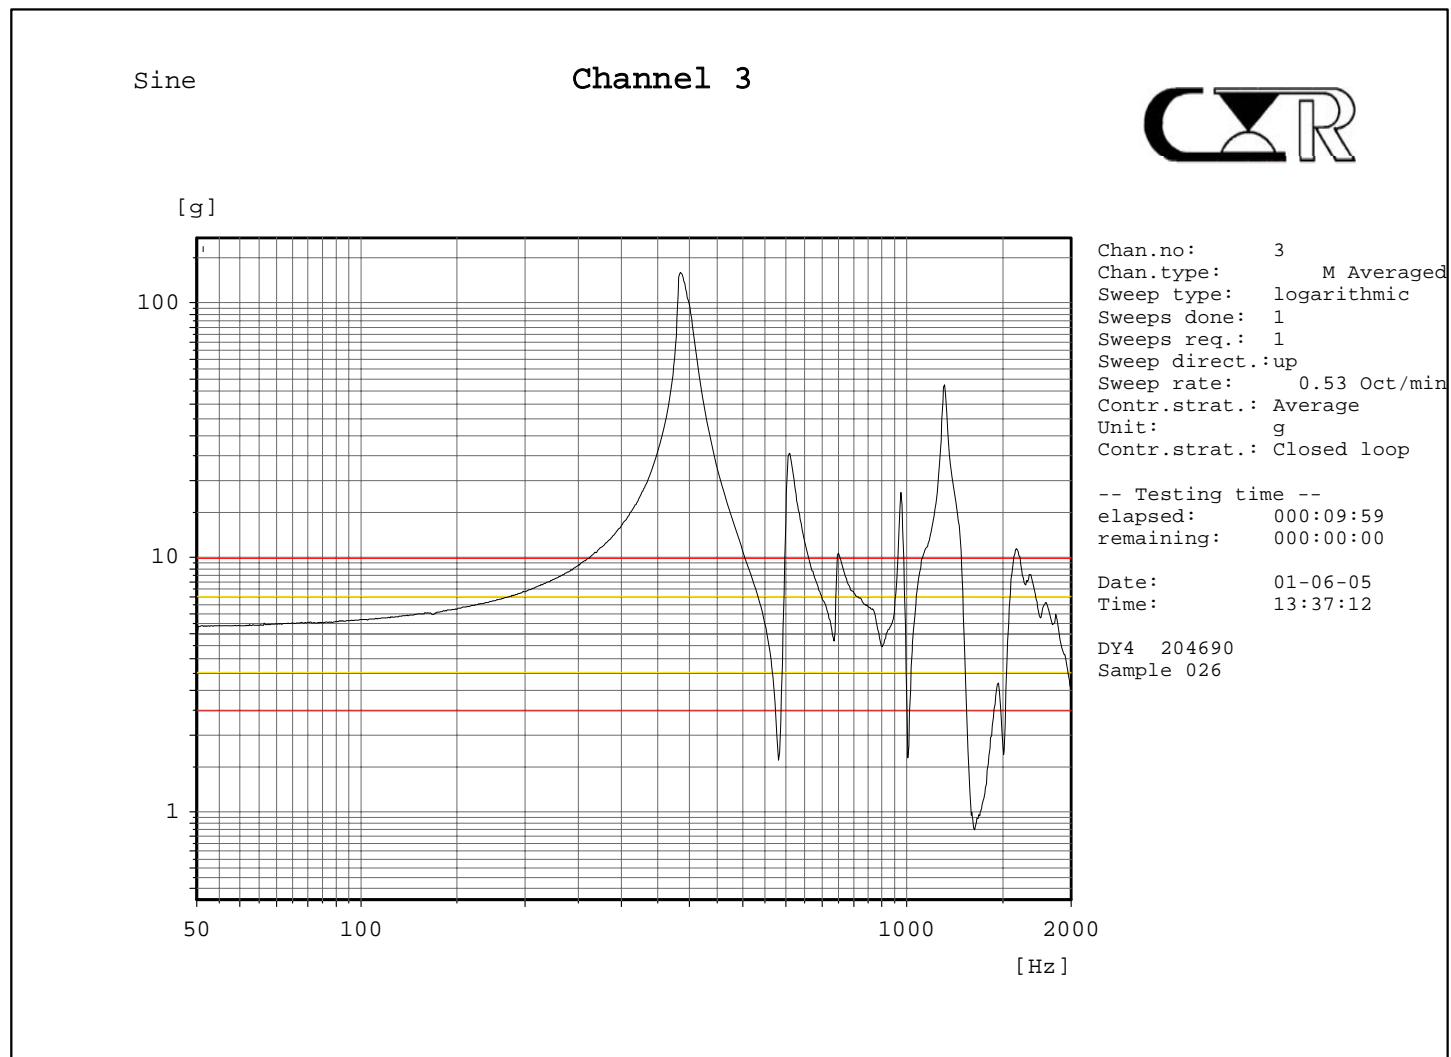
Fig. 5 Response accelerometer output (S/N 026, sine vibration)

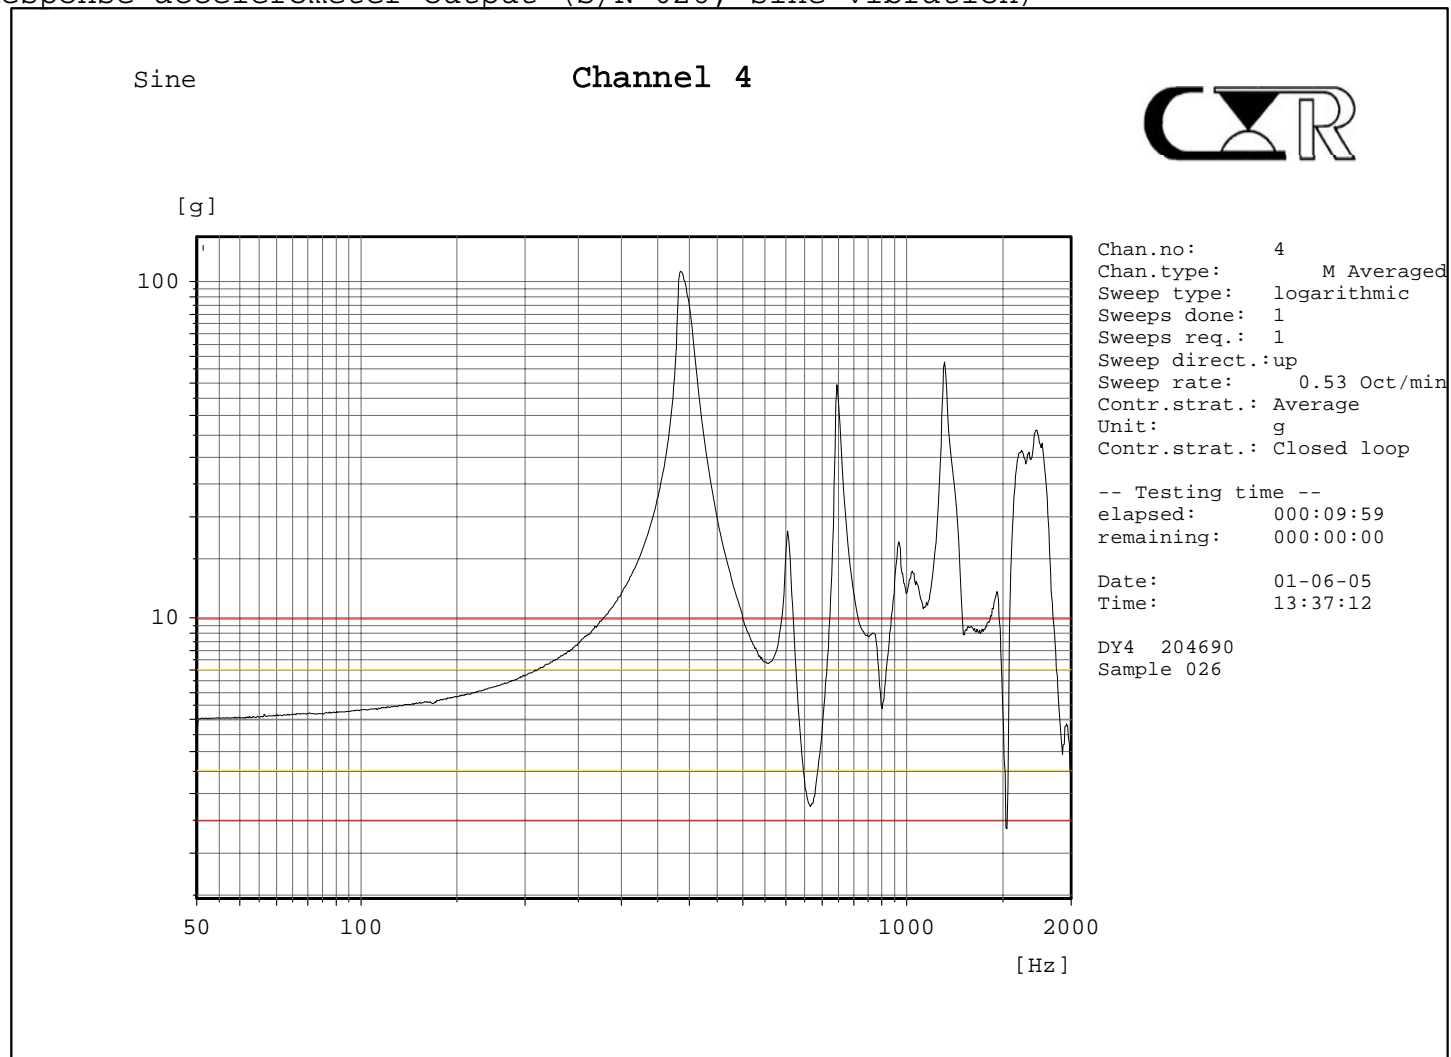
Fig. 6 Response accelerometer output (S/N 026, sine vibration)

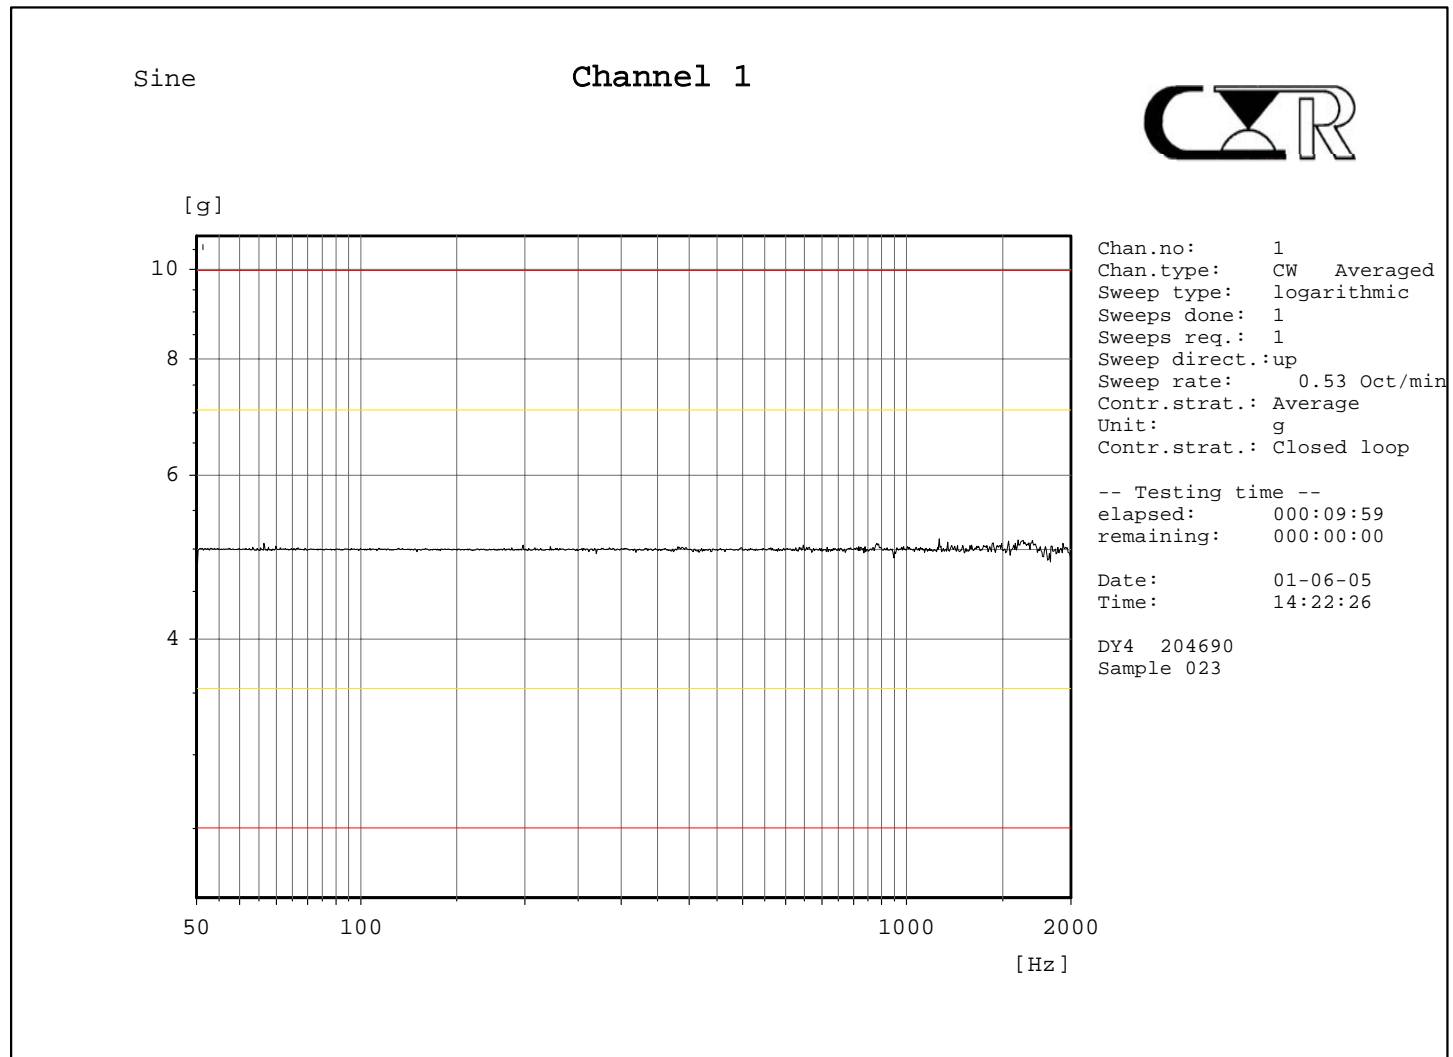
Fig. 7 Control accelerometer output (S/N 023, sine vibration)

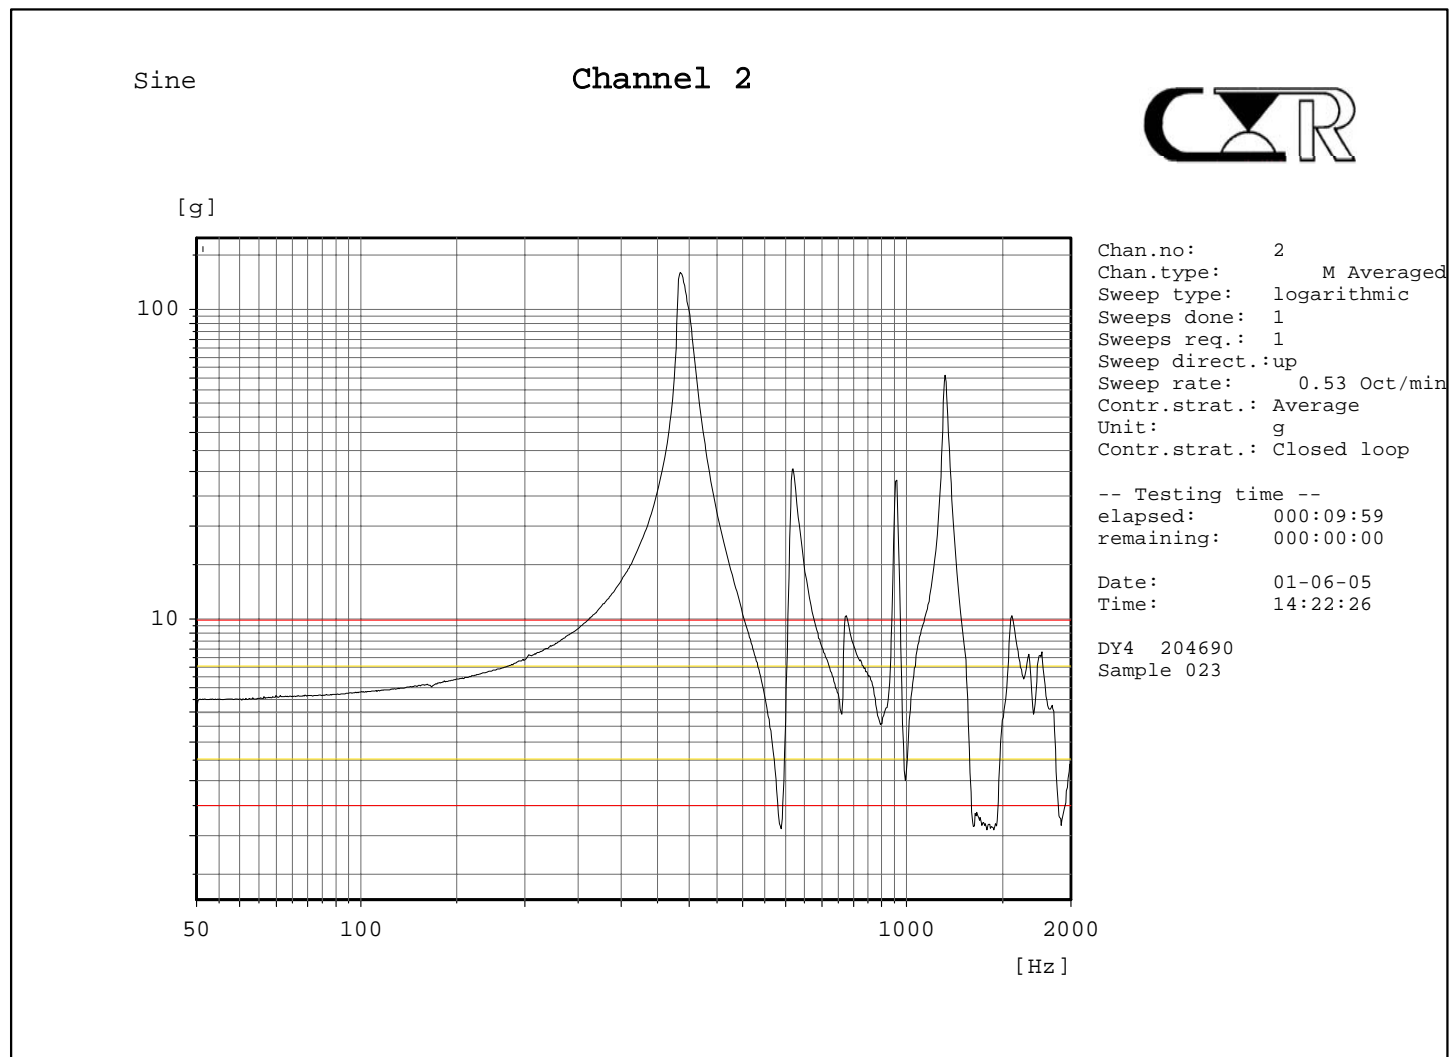
Fig. 8 Response accelerometer output (S/N 023, sine vibration)

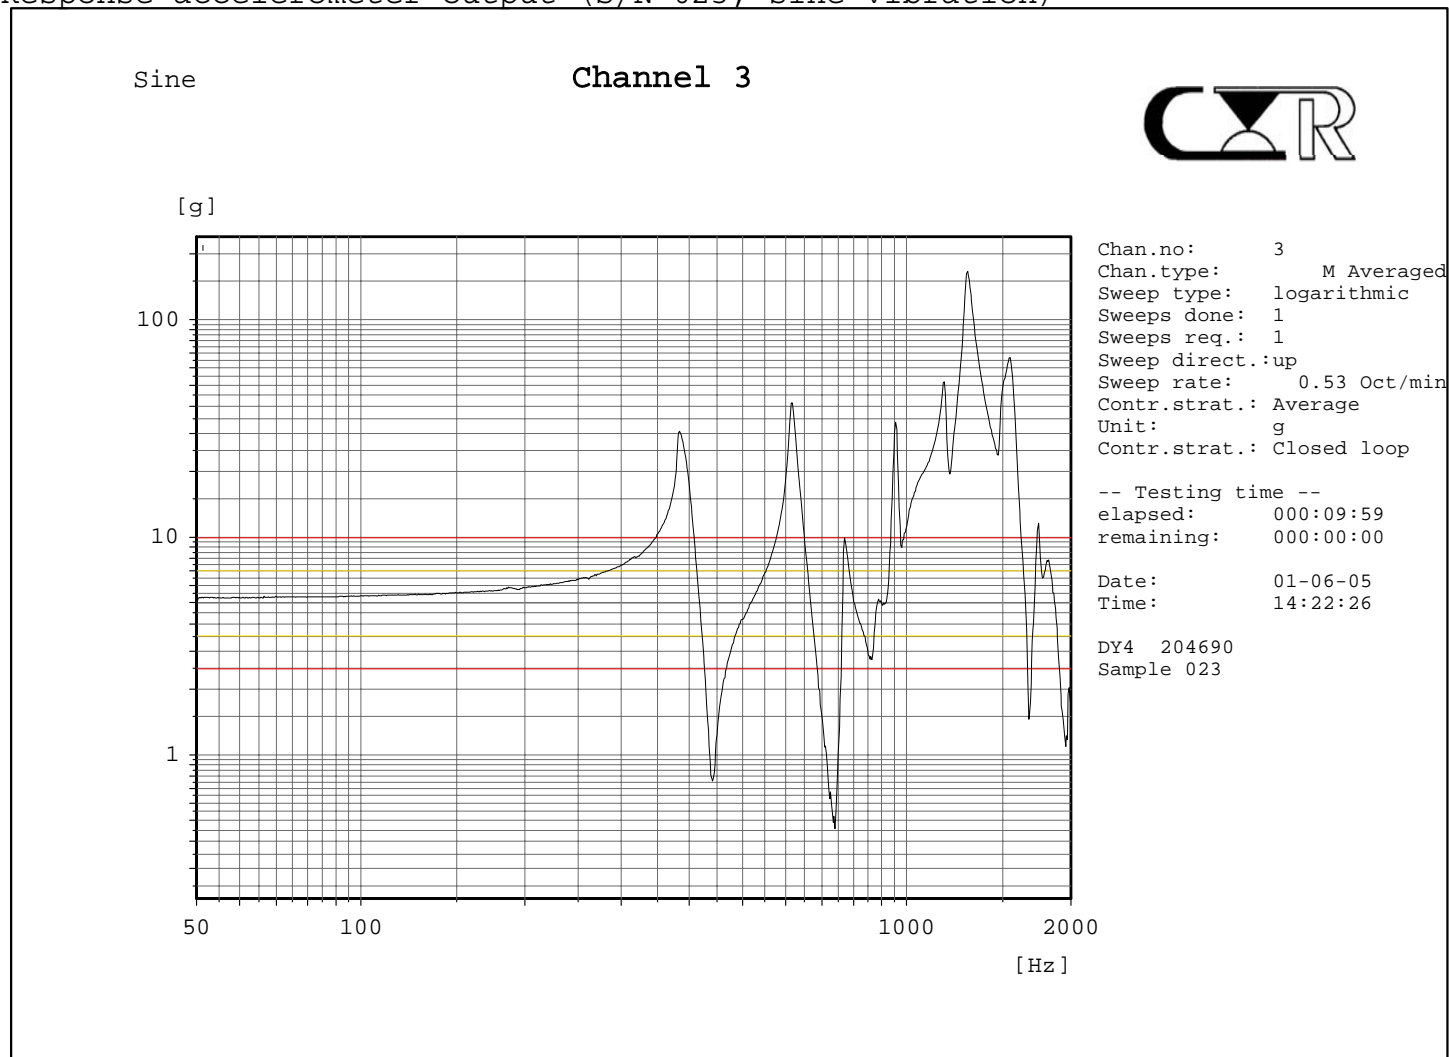
Fig. 9 Response accelerometer output (S/N 023, sine vibration)

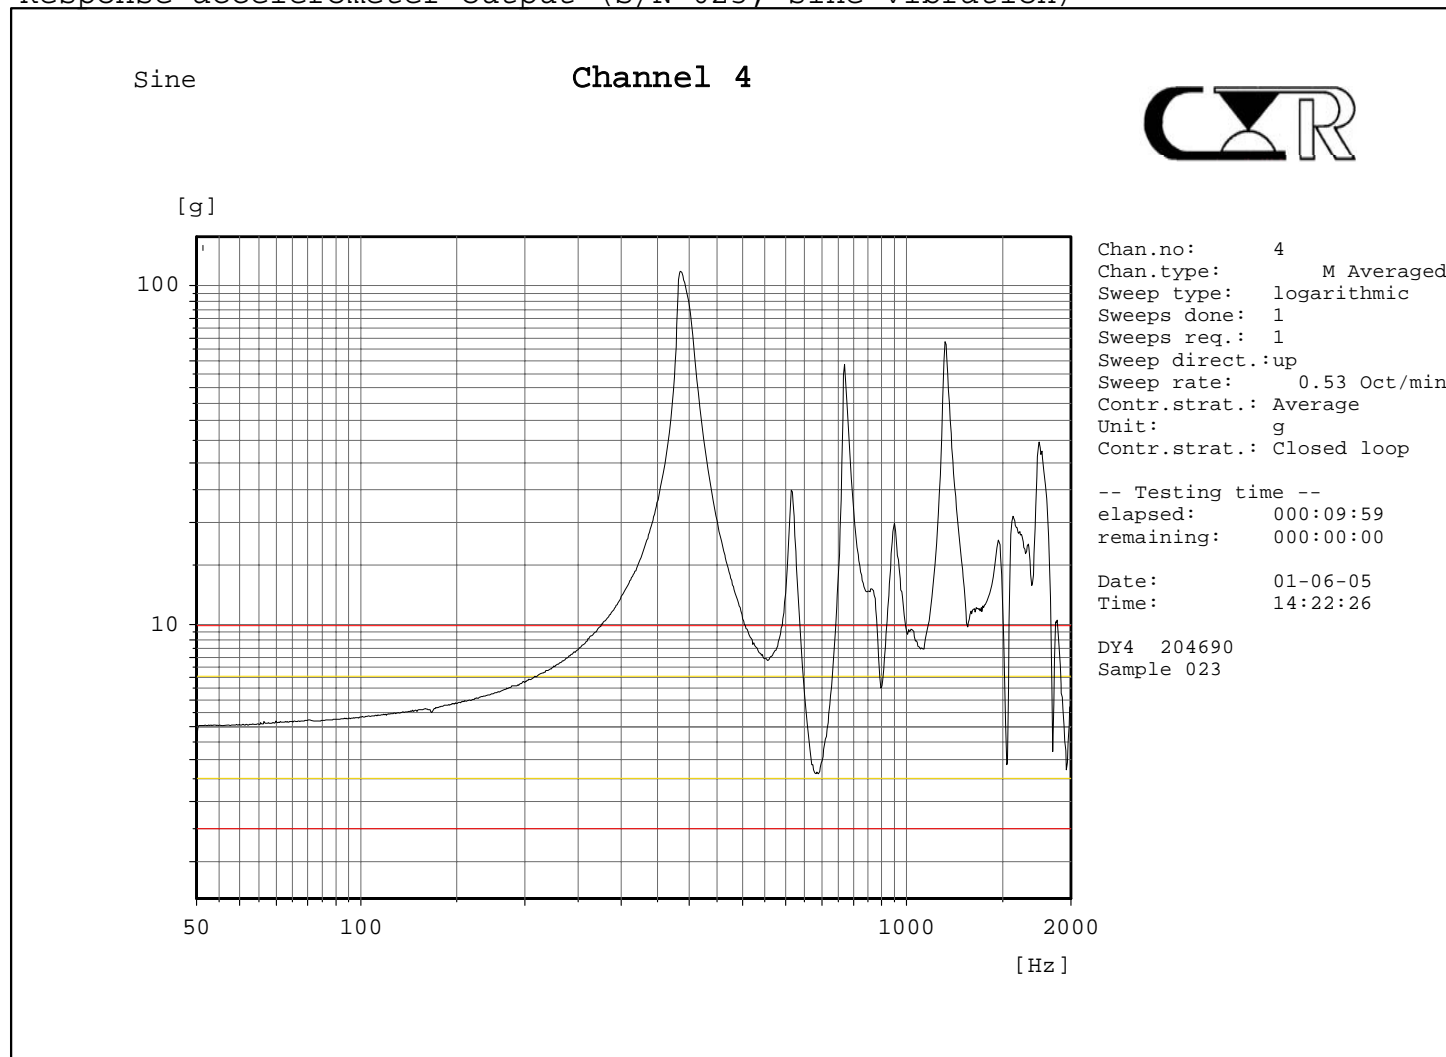
Fig. 10 Response accelerometer output (S/N 023, sine vibration)

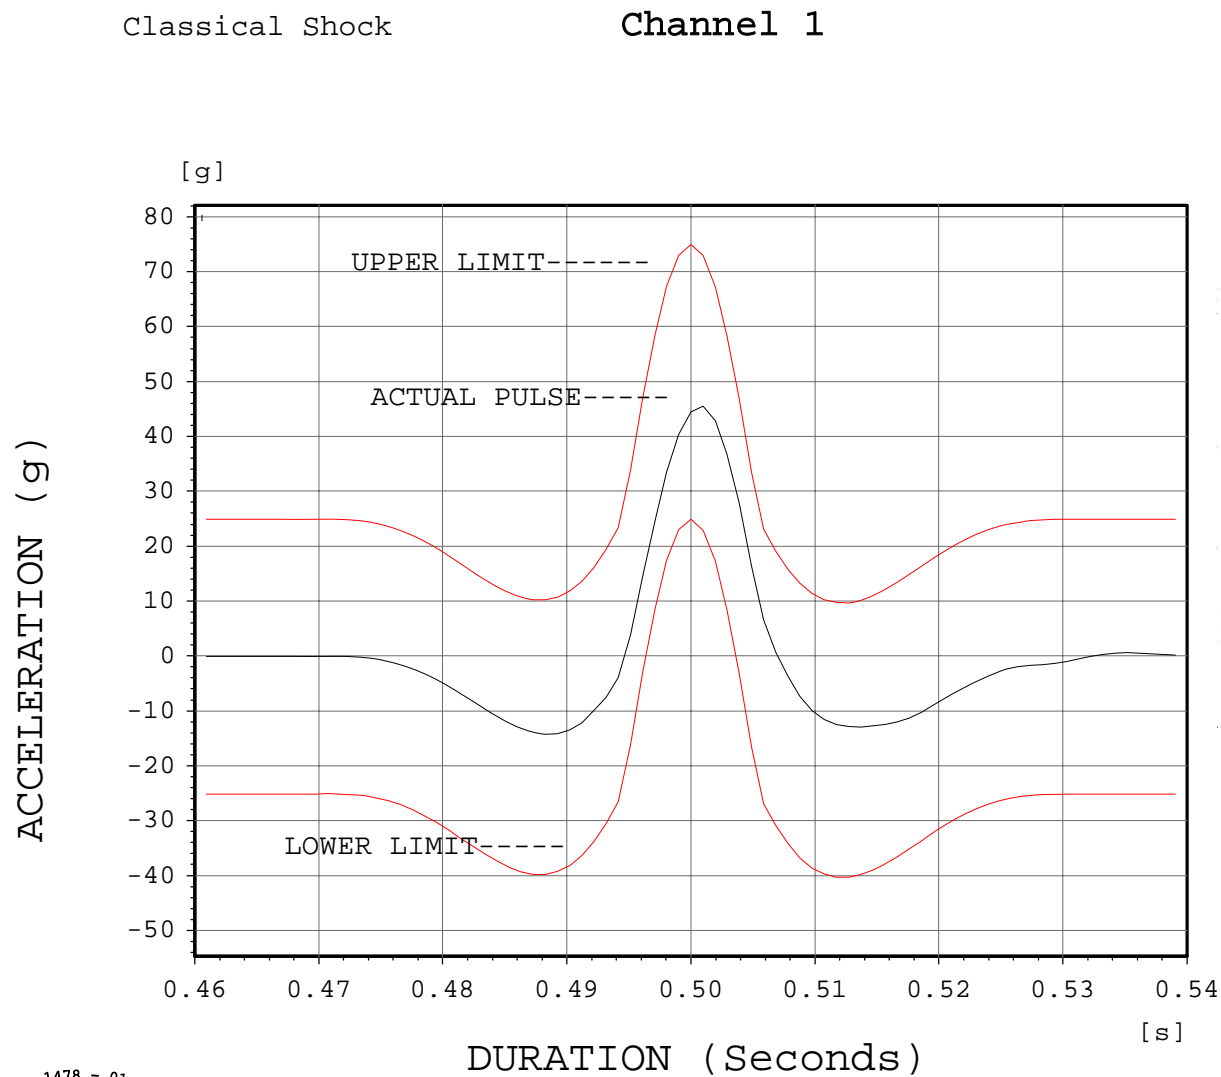
Fig. 11

Project 204690
DY4 Systems
Actual Pulse
Flat Axis
Sample ID# 023
Tech: MAG/
Date: 14Jan05

1. There was no evidence of physical damage to the test samples as tested.
2. There was no interruption greater than 10 ns.
3. See the LLCR and DWV sections for LLCR and DWV data (passed).
4. The shock plots follow:

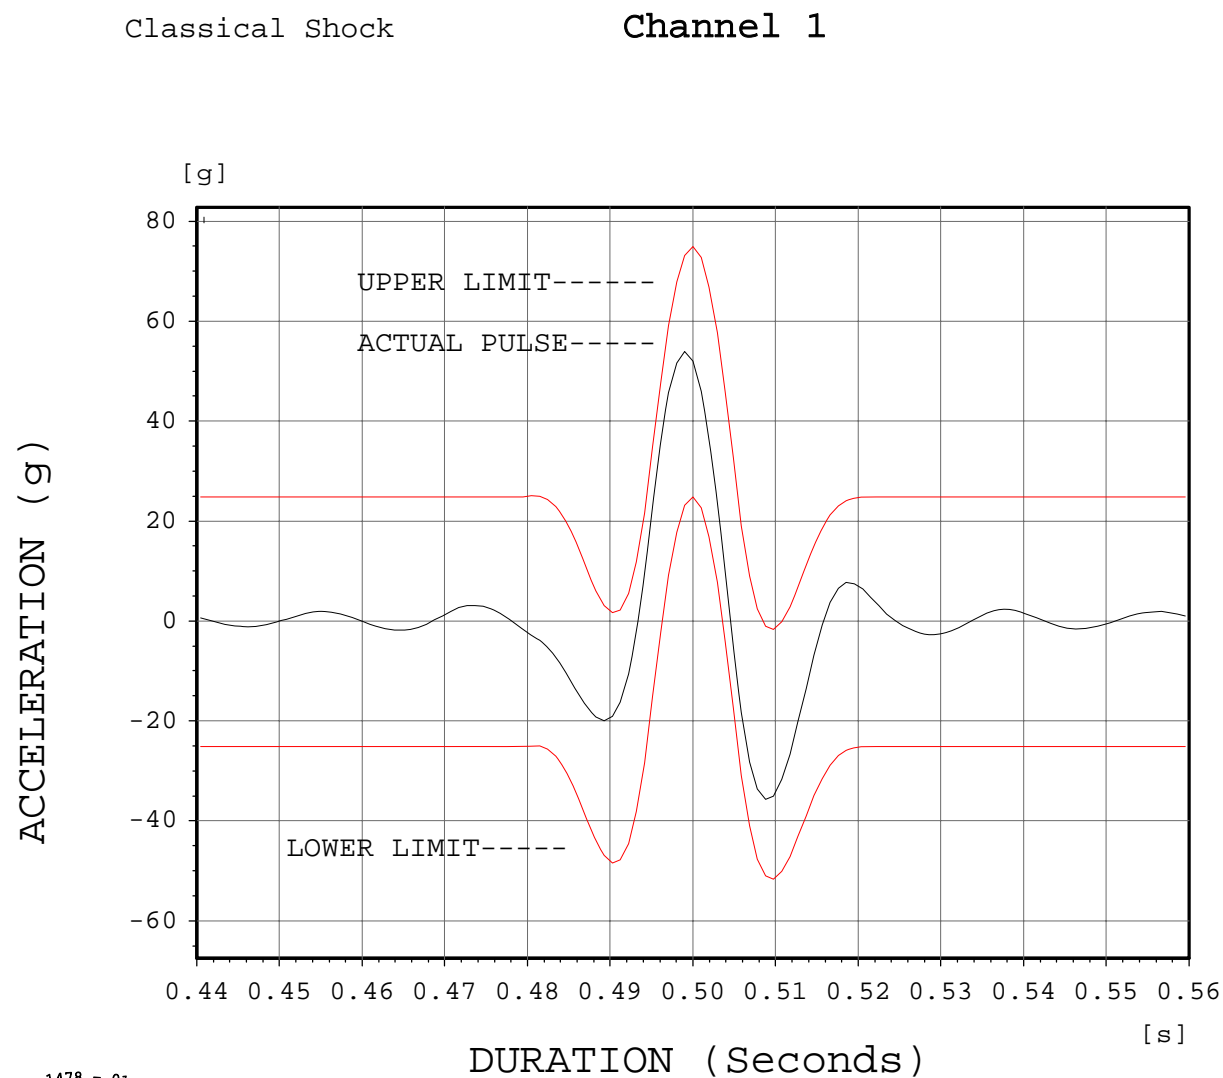
Fig. 12

Project 204690
DY4 Systems
Flat
Actual Pulse
Sample ID# 026
Tech: MAG/
Date: 10Jan05

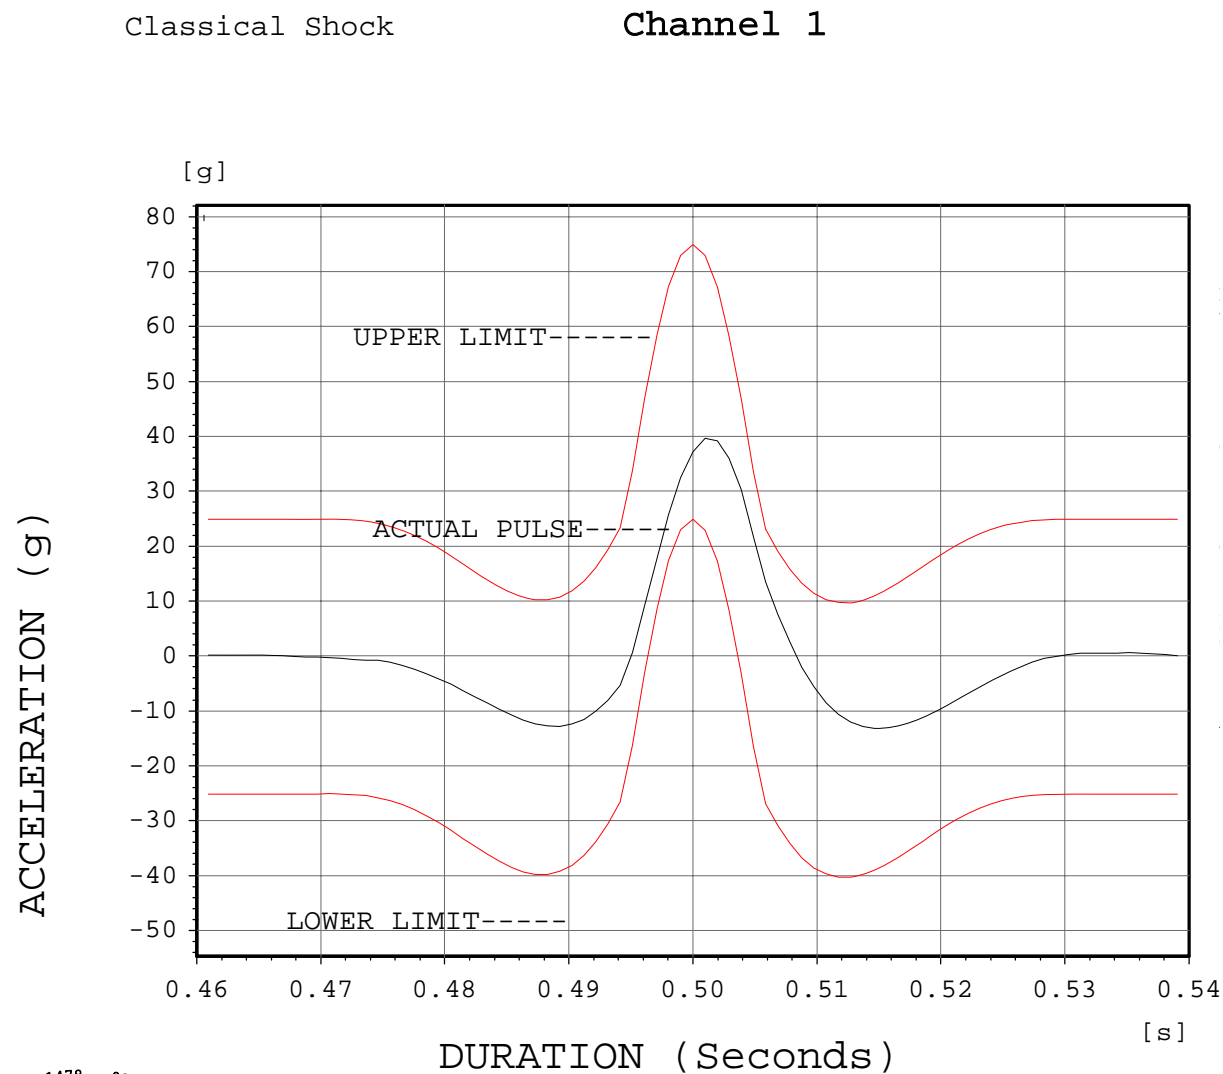
Fig. 13

Project 204690
DY4 Systems
Actual Pulse
Lat and Long Axis
Sample ID# 023
Tech: MAG/
Date: 14Jan05

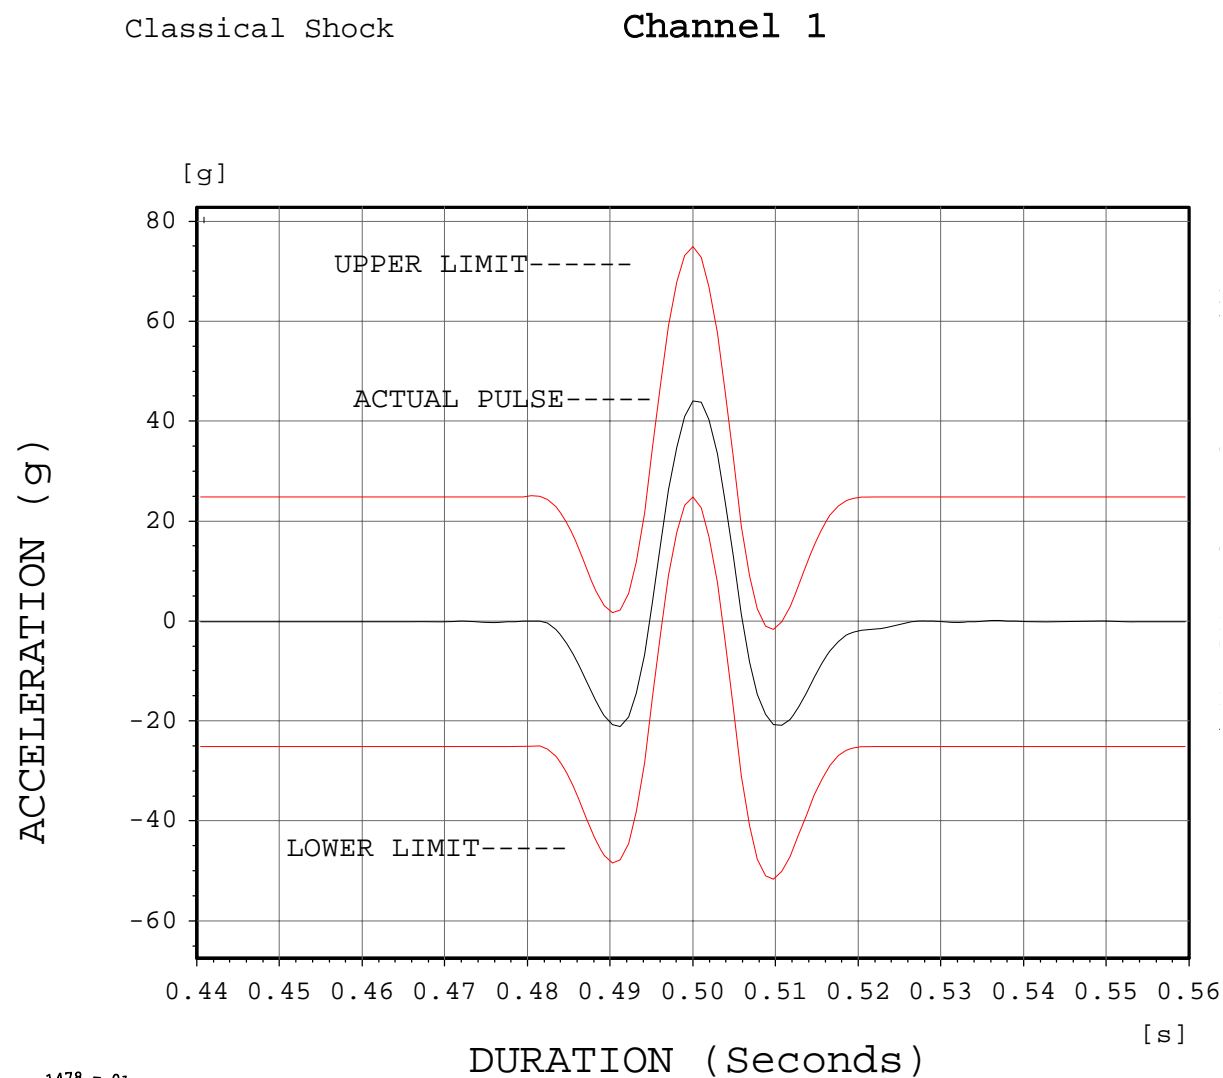
Fig. 14

Project 204690
DY4 Systems
Long
Actual Pulse
Sample ID# 026
Tech: MAG/
Date: 10Jan05

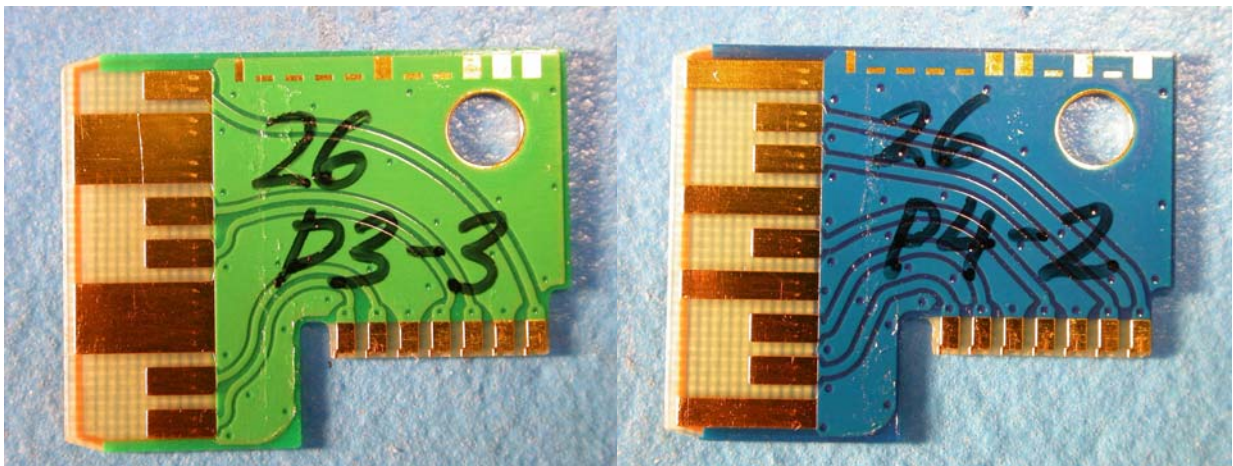
1. There was no evidence of physical damage to the test samples.
2. There was no interruption greater than 10 nanoseconds.
3. See the LLCR and DWV sections for LLCR and DWV data (passed).
4. Visual Inspection was performed on the daughtercard connector blades by removing them from their housings. All blades that were measured for LLCR or monitored for interrupts were inspected. Two of the blades are shown below. There was evidence of fretting wear, but none of the locations exhibited gold wear-through or fretting corrosion. SEM/EDS (Scanning Electron Microscopy/Energy Dispersive Spectroscopy) confirmed that gold wear-through had not occurred.

Fig. 15 Connector blades after vibration qualification

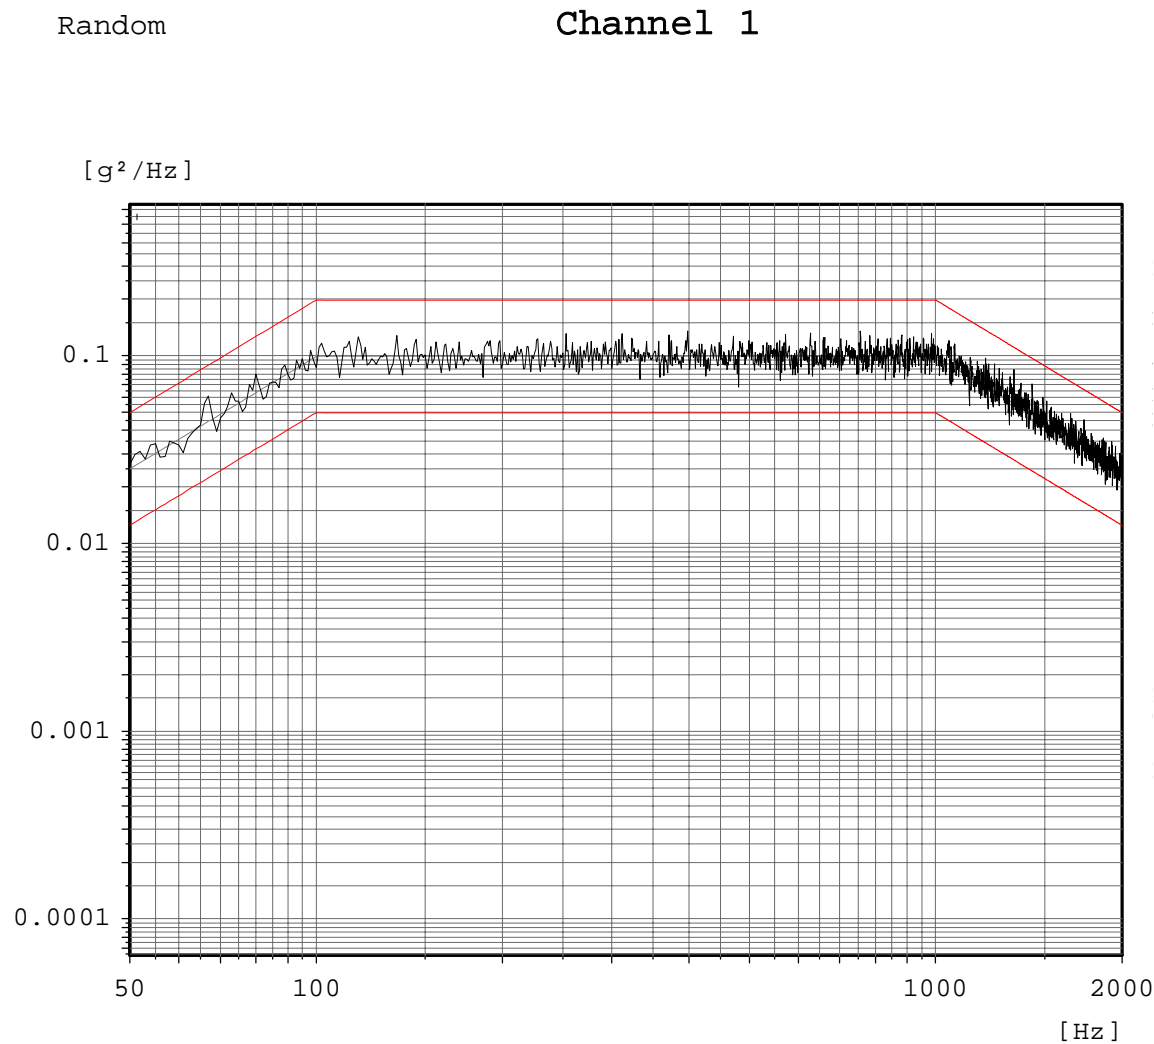
Fig. 16 Control accelerometer output (S/N 026, random vibration, lateral axis)

Project# 204690
DY4 Systems
Lateral-Axis
Test Conditions:
ID# 026
Tech: MAG
Date: 11Jan05

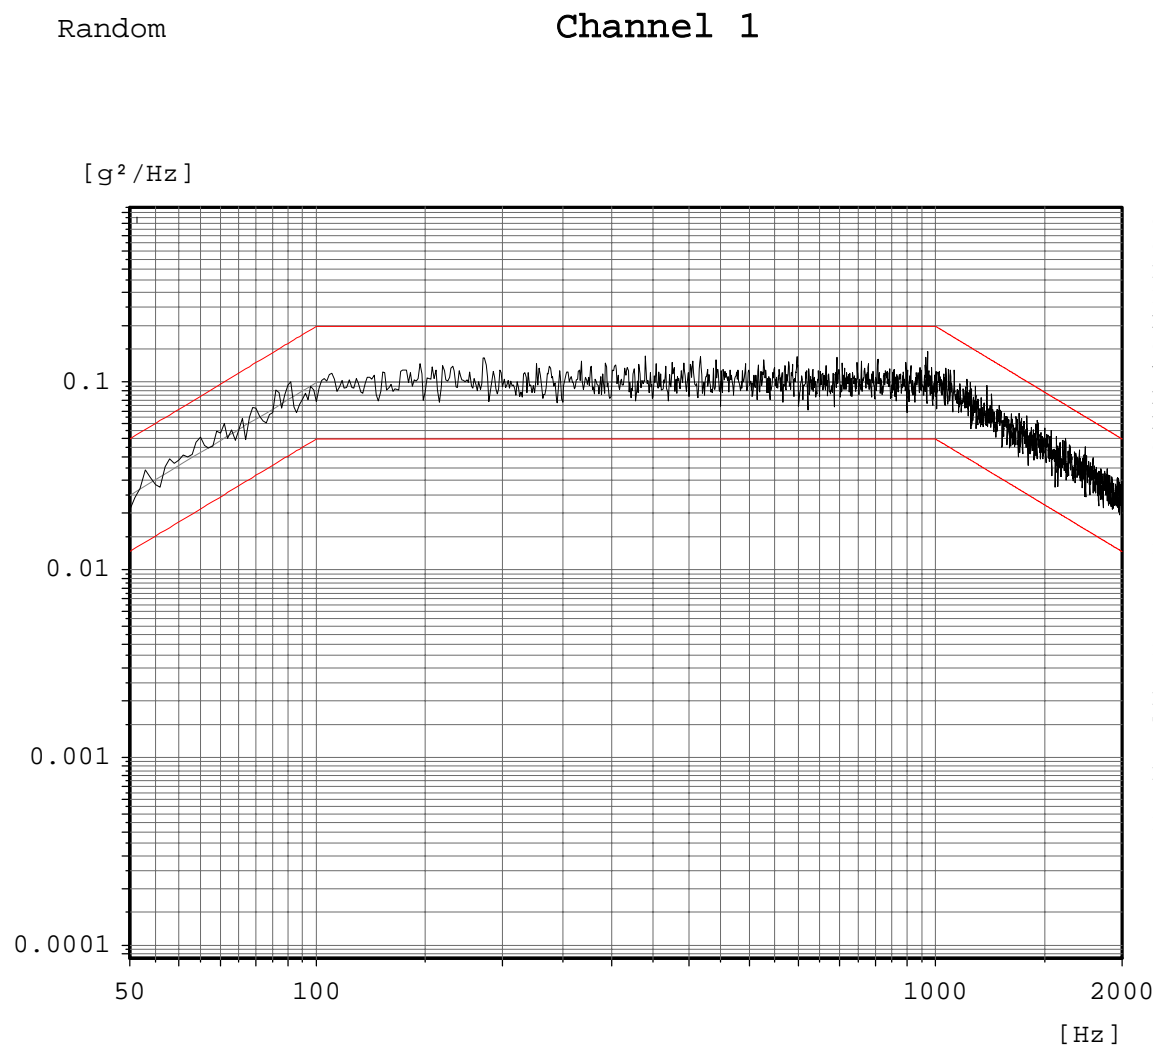
Fig. 18 Control accelerometer output (S/N 026, random vibration, long axis)

Project# 204690
DY4 Systems
Longitudinal-Axis
Test Conditions:
ID# 026
Tech: MAG
Date: 11Jan05
