TEST REPORT #204690

VITA 46 CONNECTOR/MODULE QUALIFICATION TEST

To perform qualification testing of the VITA 46 Connector Set as manufactured and submitted by the test sponsor, Curtiss-Wright Controls Embedded Computing.

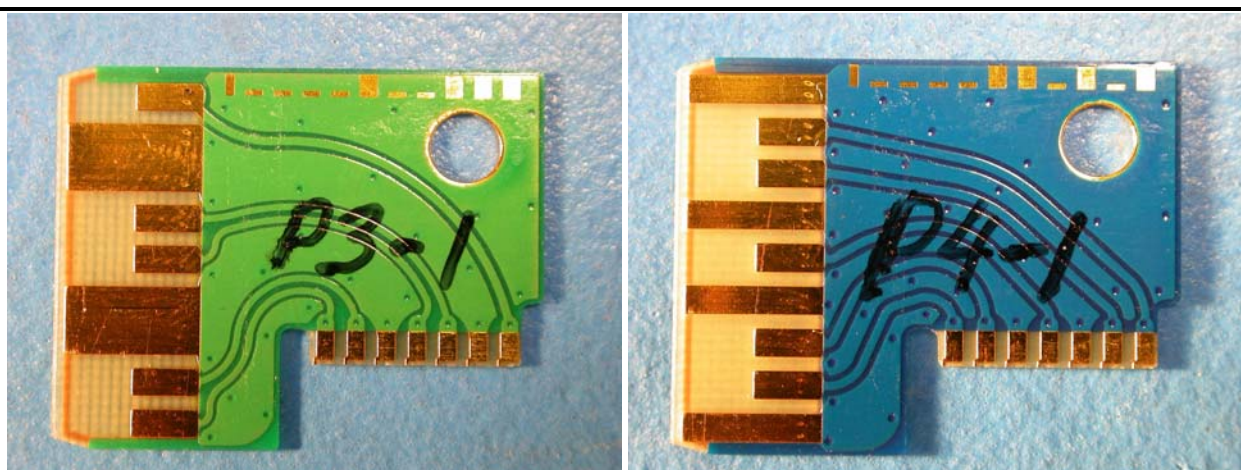
1. There was no evidence of physical damage to the test samples.
2. There was no interruption greater than 10 nanoseconds.
3. See the LLCR and DWV sections for LLCR and DWV data (passed).
4. Visual Inspection was performed on the daughtercard connector blades by removing them from their housings. All blades that were measured for LLCR or monitored for interrupts were inspected. Two of the blades are shown below in Fig. 19. There was evidence of fretting wear, and in some spots gold wear-through, with the worst case showing fretting corrosion debris (P3-1 blade, top contact). SEM/EDS confirmed that gold wear-through had occurred to the nickel underplate.

The contact with fretting corrosion debris was not being monitored for interrupts, nor measured for LLCR, so a determination of if or when it failed could not be made (also, note that only one of the two redundant contacts had fretting corrosion debris). Other contacts which showed gold wear-through, and were being monitored and measured, did not fail interrupt monitoring or LLCR.

Using the visual inspection criteria of the VITA 46 Test Plan, the gold wear-through and fretting corrosion locations established that the vibration limit (for the test vehicle used) was between $0.1 \text{ G}^2/\text{Hz}$ and $0.2 \text{ G}^2/\text{Hz}$, 50-2000 Hz, 1.5 hours/axis. The other criteria (LLCR and interrupt monitoring) give a higher vibration limit (i.e. $>0.2 \text{ G}^2/\text{Hz}$).

Fig. 19 Connector blades after HALT stepped vibration

In addition, other approaches can be used to increase vibration life. For example, increased stiffening of the plug-in module will reduce displacements under vibration.

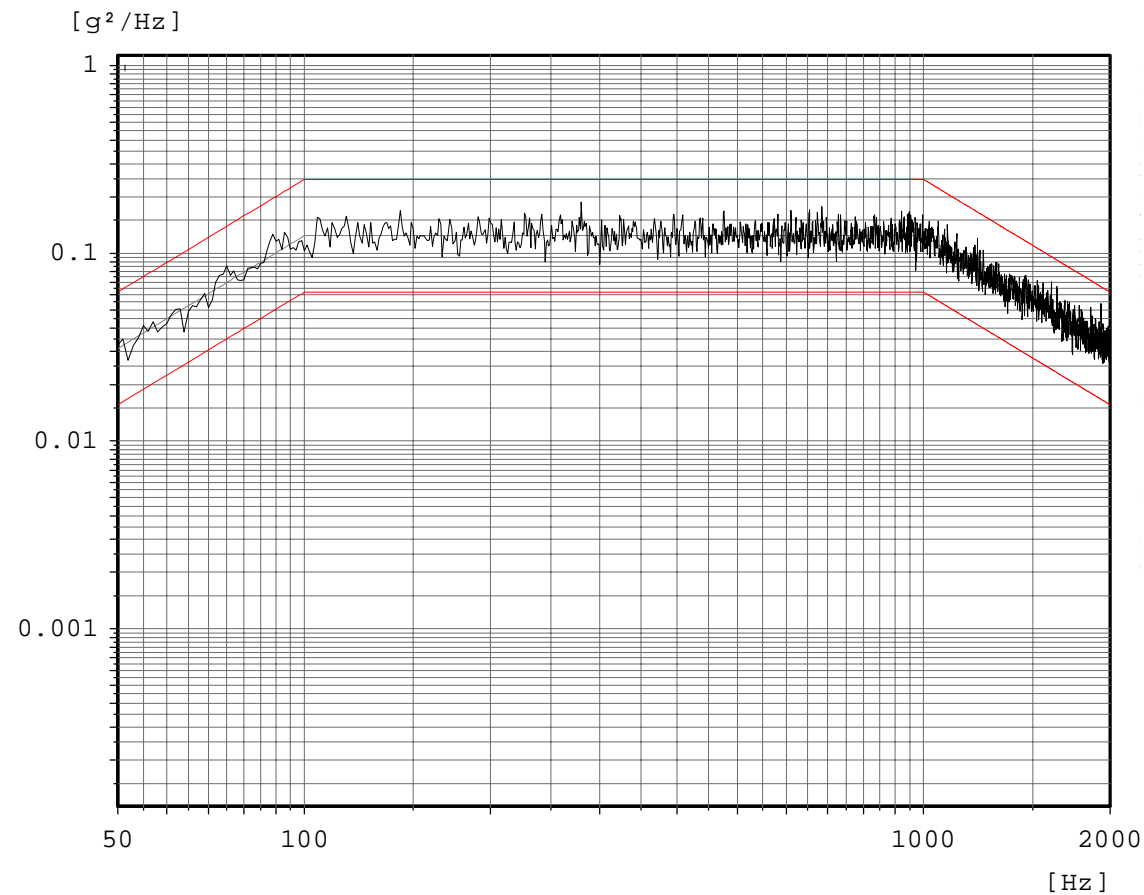
Fig. 20 Control accelerometer output (S/N 023, stepped random vibration, flat axis)

Project# 204690
DY4 Systems
Flat-Axis ID 023
Test Conditions:
0.125 G2/Hz
Tech:MAG
Date:20Jan05

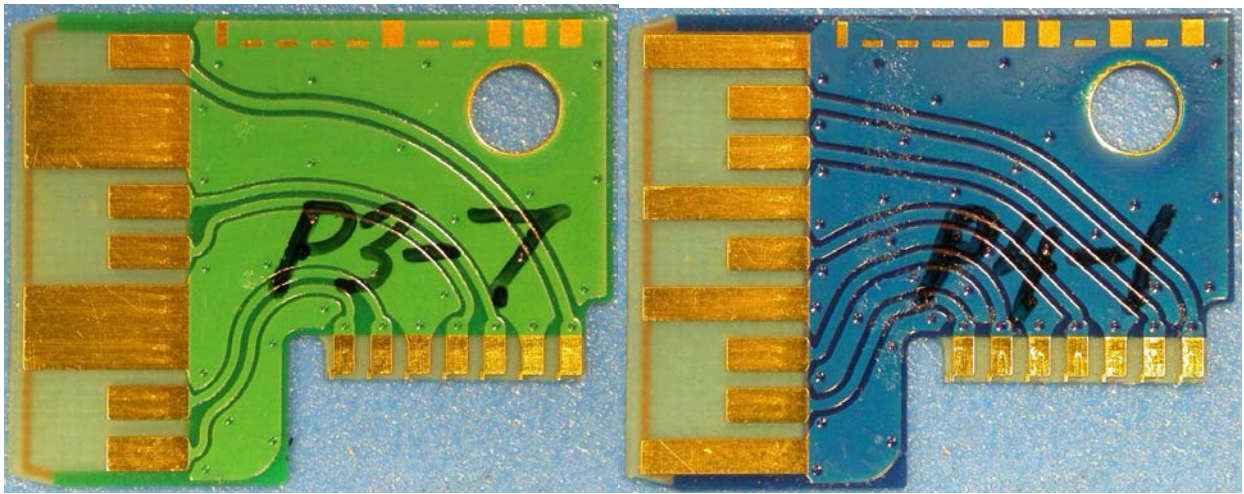
1. There was no evidence of physical damage to the test sample as tested.
2. There was no interruption greater than 10 nanoseconds.
3. See the LLCR and DWV sections for LLCR and DWV data (passed).
4. Visual Inspection was performed on the daughtercard connector blades by removing them from their housings. Two of the blades are shown below. There was evidence of fretting wear, but none of the locations showed gold wear-through.

Fig. 32 Connector blades after combined vibration/temperature

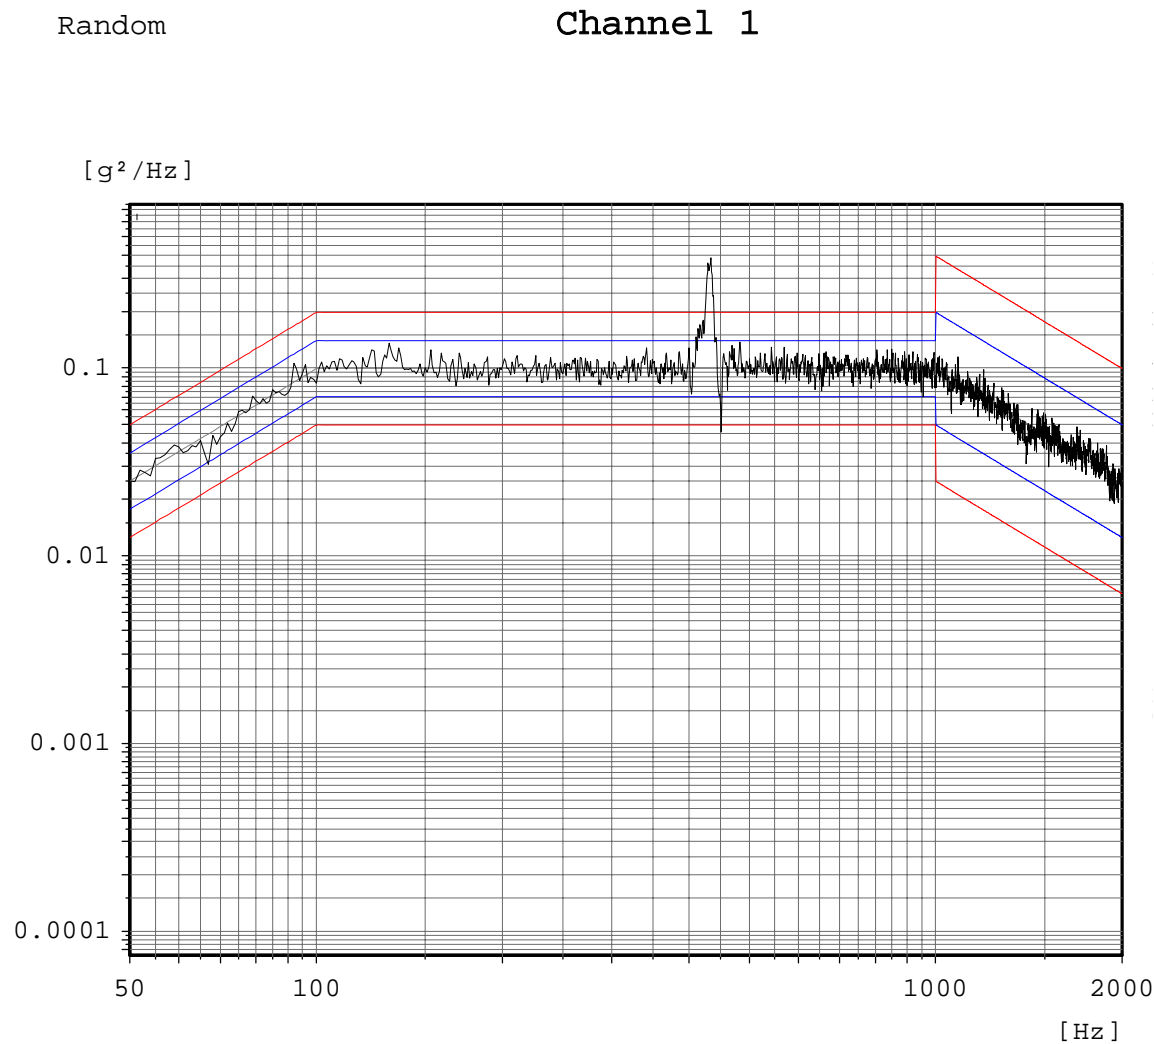
Fig. 33 Control accelerometer output (S/N 027, vibration/temp., flat axis)

Project# 204690
DY4 Systems
Flat-Axis
Test Conditions:
Method 2005.1 VD
Tech: MAG
Date: 09Mar05

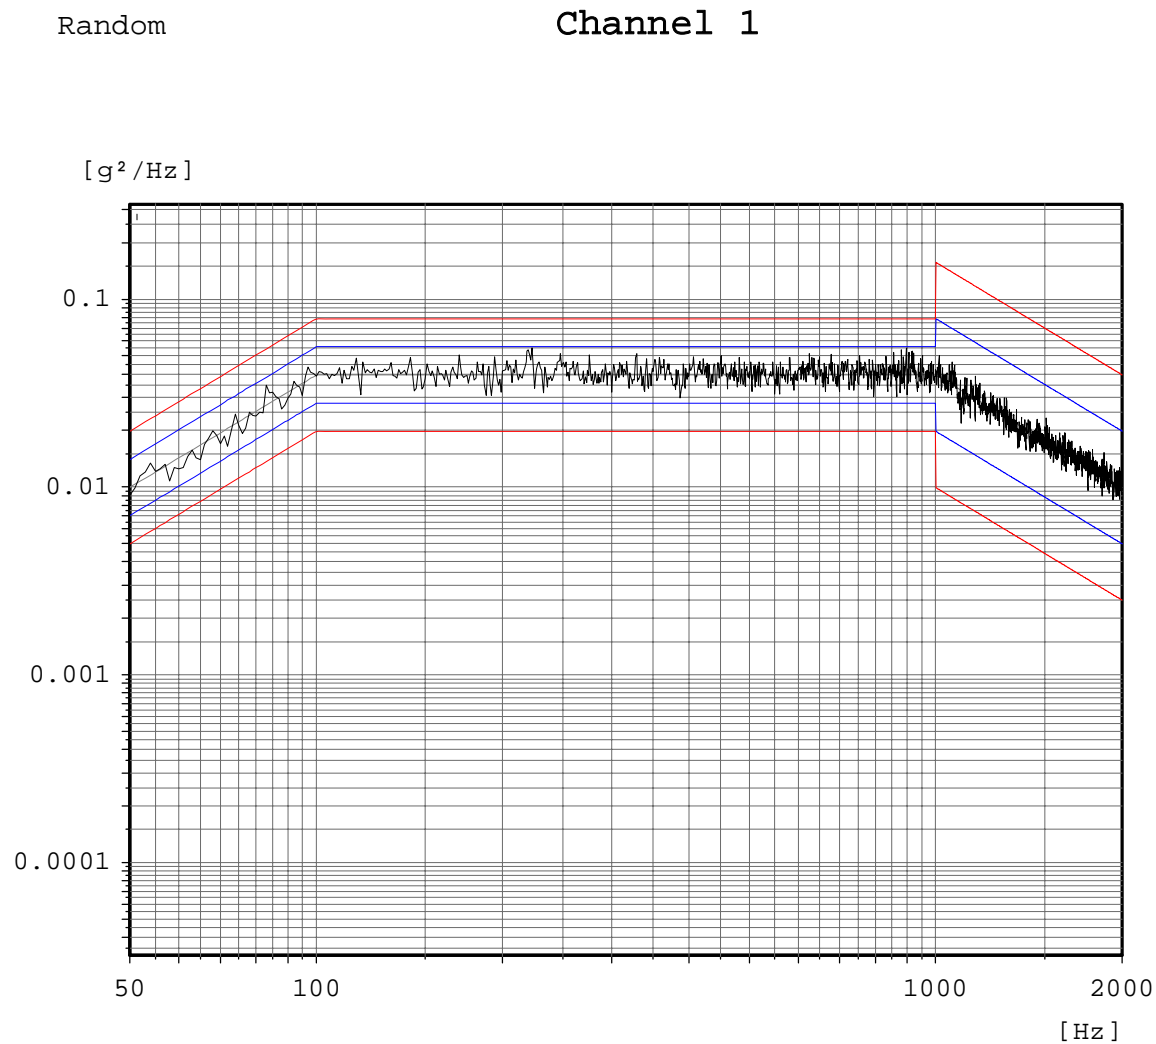
Fig. 34 Control accelerometer output (S/N 027, vibration/temp., lateral axis)

Project# 204690
DY4 Systems
Lateral-Axis
Test Conditions:
Method 2005.1 VD
Tech: MAG
Date: 10Mar05

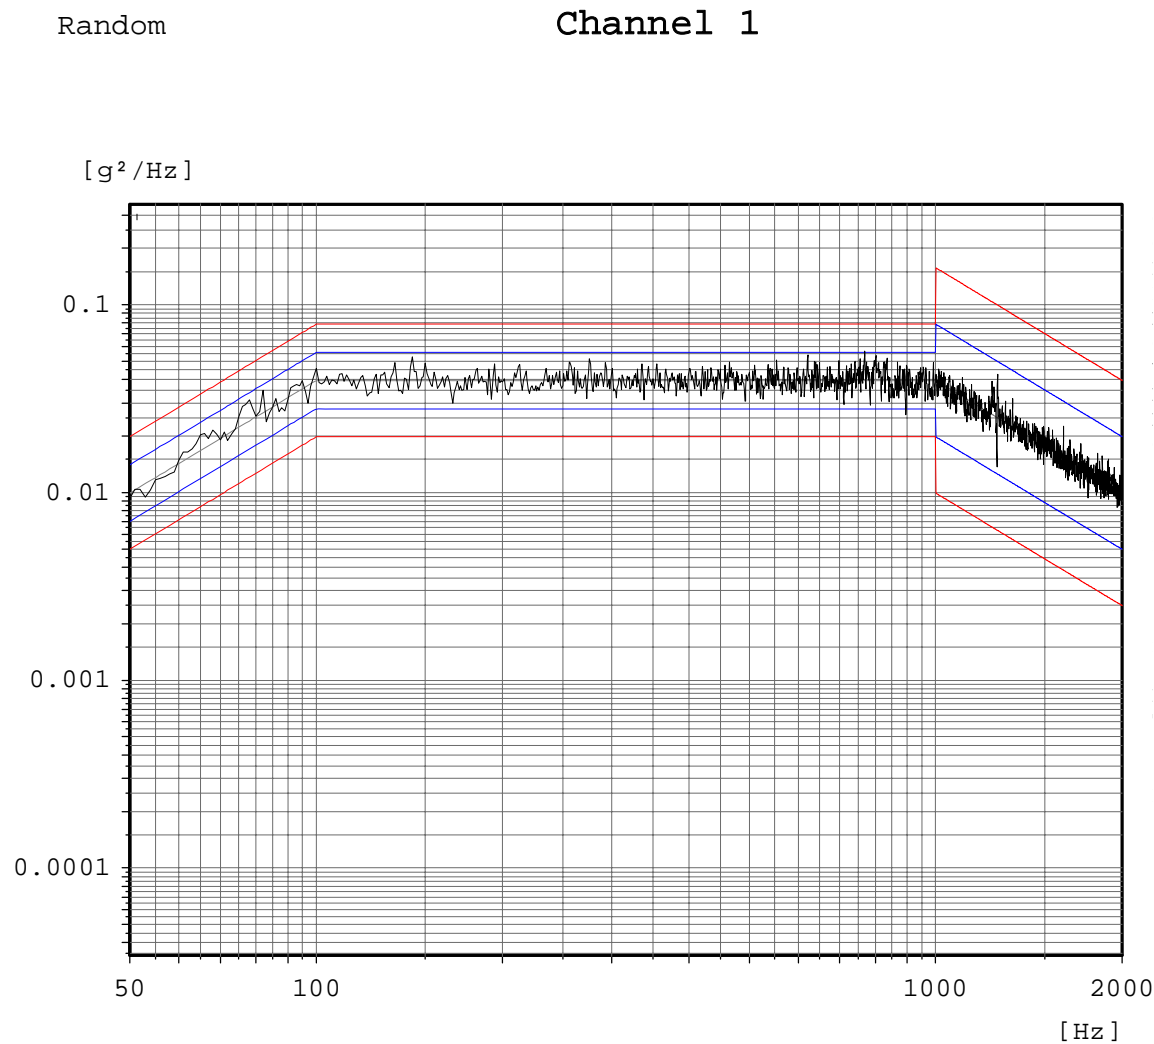
Fig. 35 Control accelerometer output (S/N 027, vibration/temp., long axis)

Project# 204690
DY4 Systems
Longitudinal-Axis
Test Conditions:
Method 2005.1 VD
Tech: MAG
Date: 09Mar05

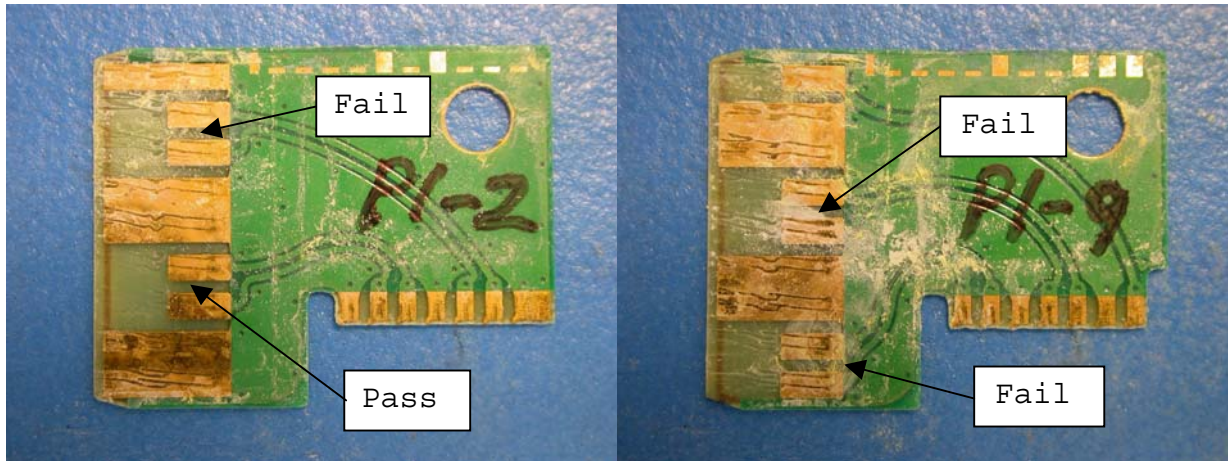
1. 6 of 16 DWV measurement locations failed due to high leakage current.
2. The following is a summary of the observed data.

3. Visual inspection results showed that the DWV failures were caused by salt bridges (see below)

Fig. 36 Connector blades after 500 hr. salt fog

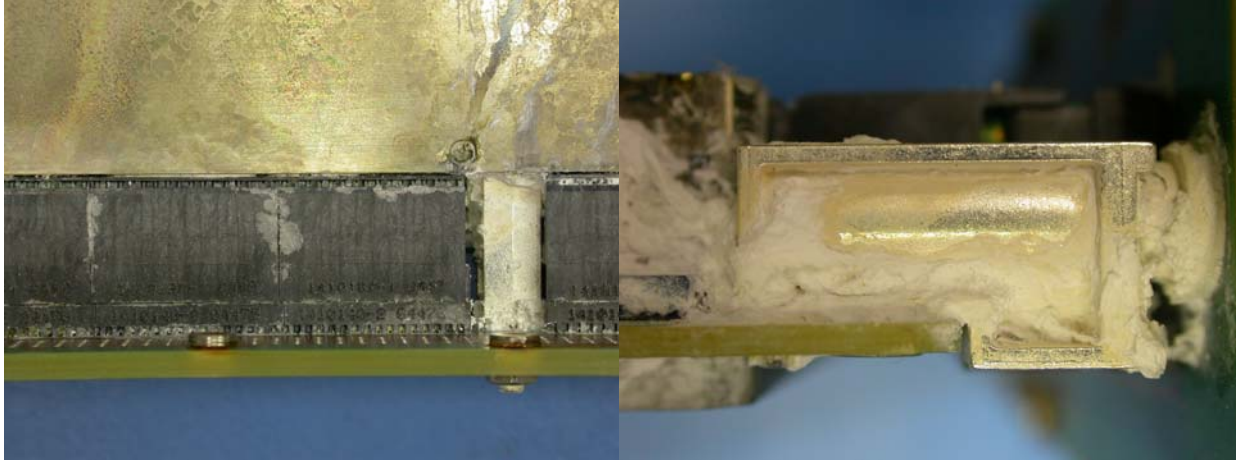
1. There was no evidence of corrosion of the connectors, however heavy salt deposits were present (see Fig. 37 below).

Fig. 37 VITA 46 test module after 500 hr. salt fog

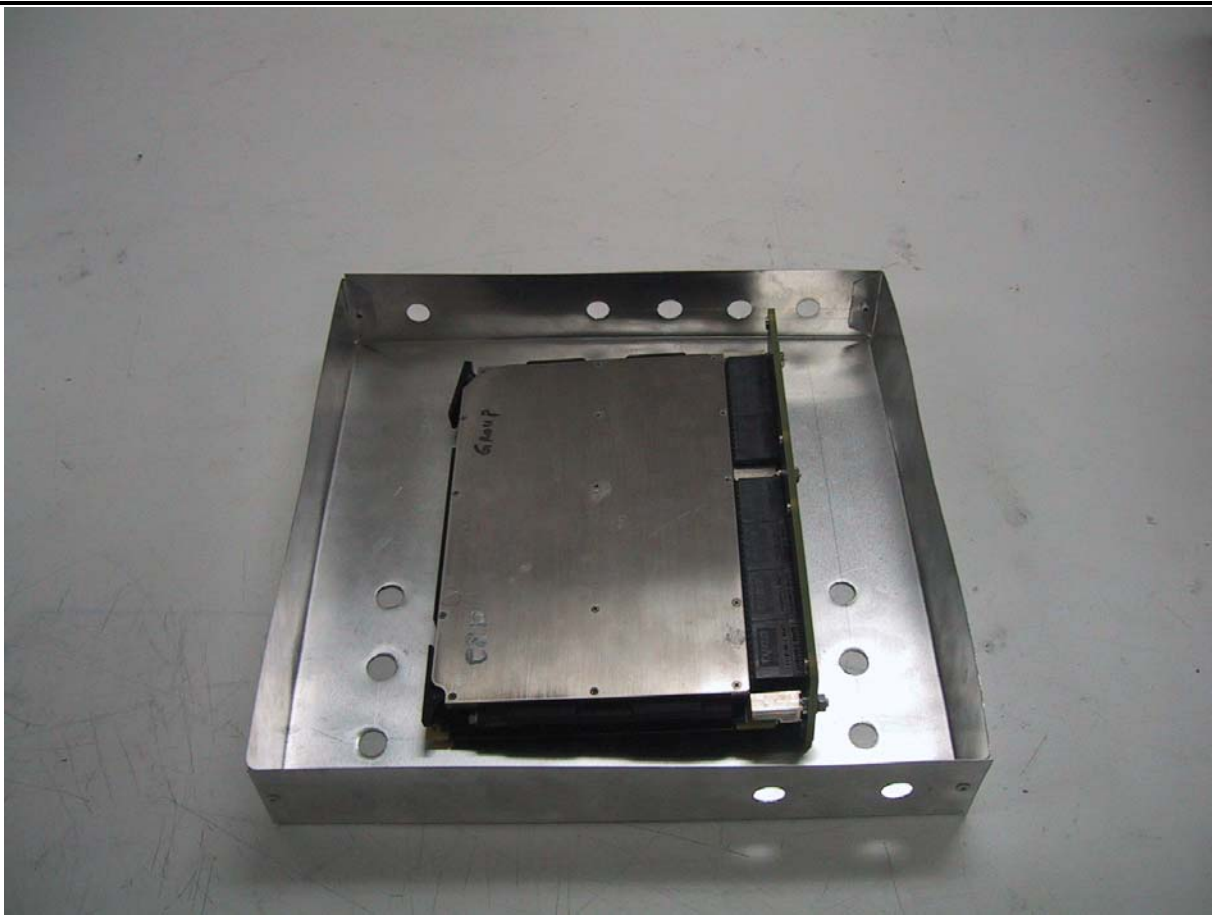
2. Unless otherwise indicated, all materials were certified by the manufacturer to be in accordance with the applicable product specification.
3. The test samples as submitted were certified by the manufacturer as being fabricated and assembled utilizing normal production techniques common for this type of product and inspected in accordance with the quality criteria as established for the product involved.
4. The test sample was tested in its 'as received' condition, using an enclosure as shown below (top cover not shown).

Fig. 38 Enclosure for salt + SO₂ test (top cover not shown)

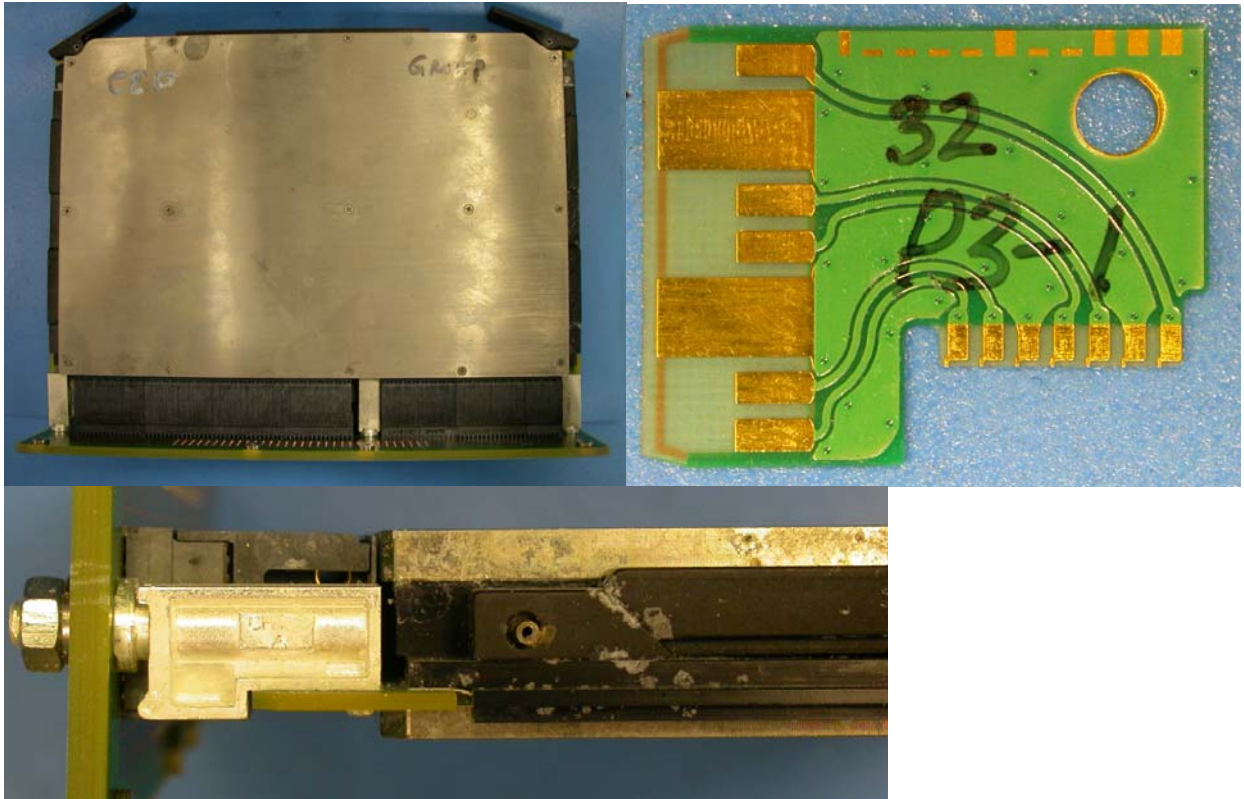
4. Visual inspection showed considerably less salt deposits than for the UUT that underwent the 500 hour salt test. There was no evidence of corrosion on the connectors or on metal surfaces, and no salt bridges were present on the connector blades or backplane connector contacts (see below).

Fig. 39 VITA 46 test module after salt + SO₂

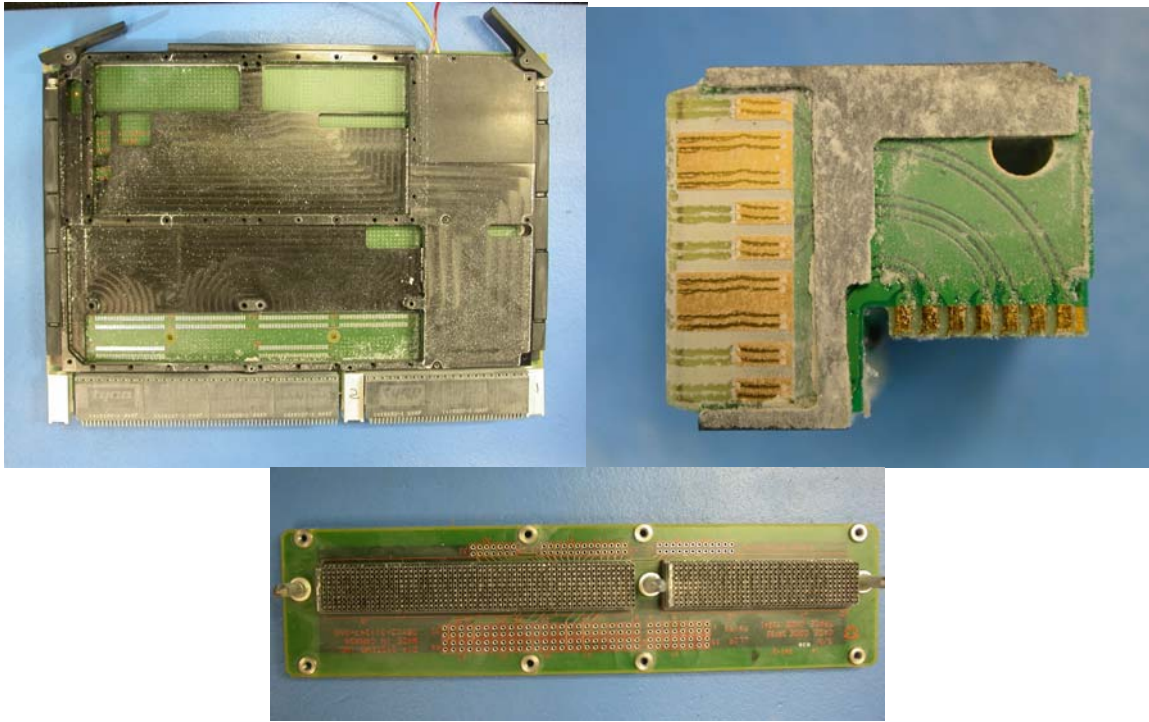
There was no evidence of physical damage to the test sample as exposed (see Fig. 40). Also see LLCR and DWV results above (passed).

Fig. 40 Dust and sand test vehicle (clockwise from top left: daughtercard, P3 connector, backplane)

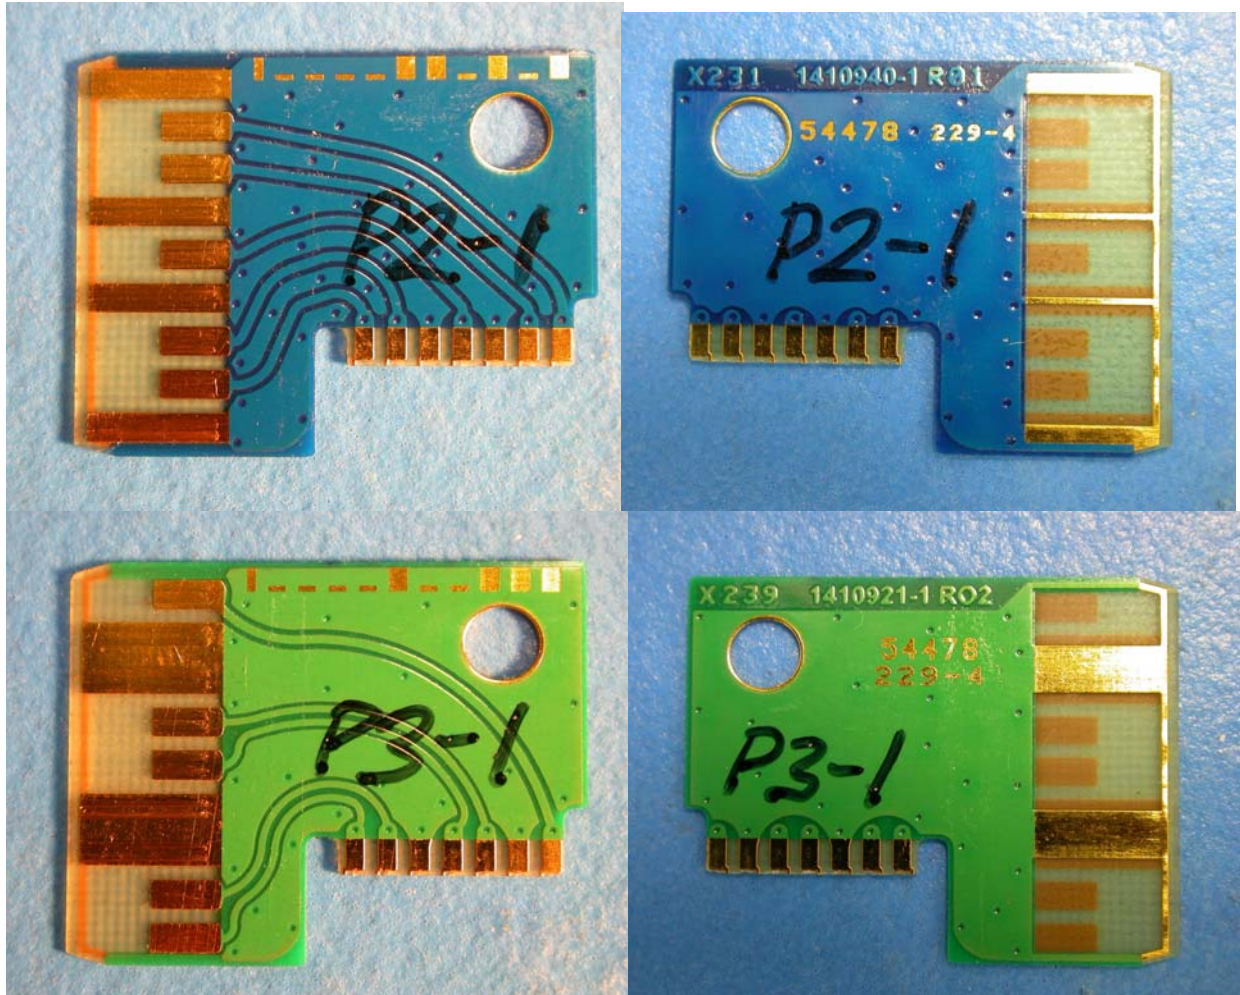
1. There was no evidence of physical damage to the test samples as tested. Visual Inspection was performed on the daughter-card connector blades by removing them from their housings. Two of the blades are shown below. Wear tracks were evident, but none of the locations showed gold wear-through.

Fig. 41 Connector blades after 500 cycles of durability

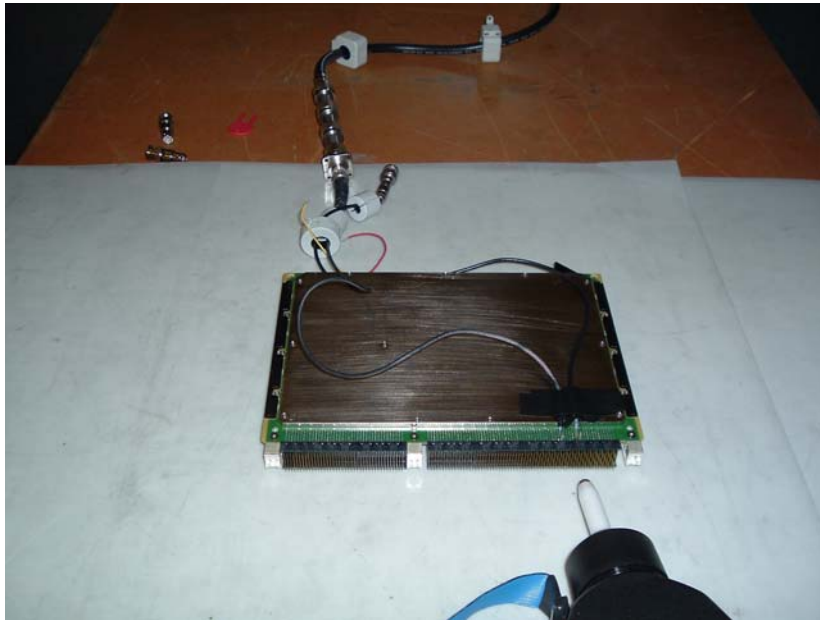
Fig. 42 ESD Test module

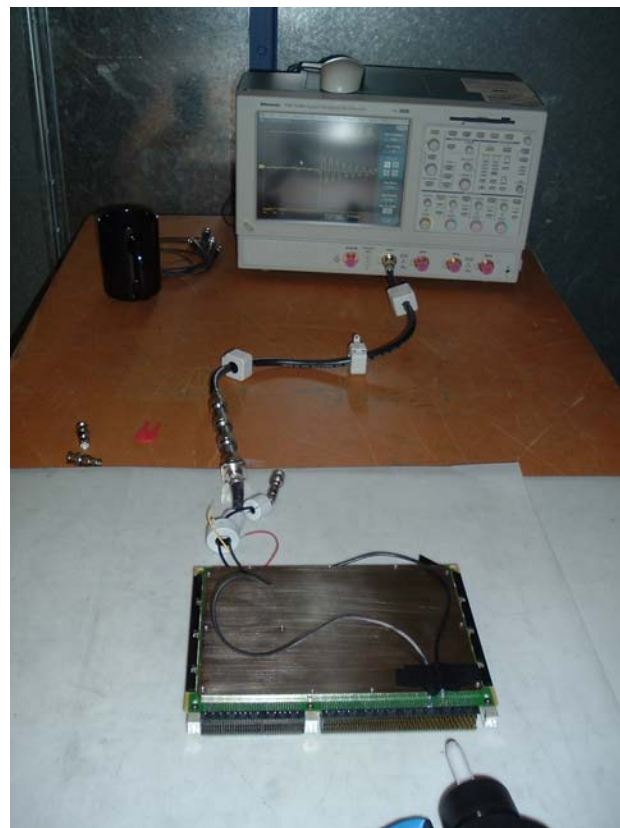
Fig. 43 ESD Test Set-up

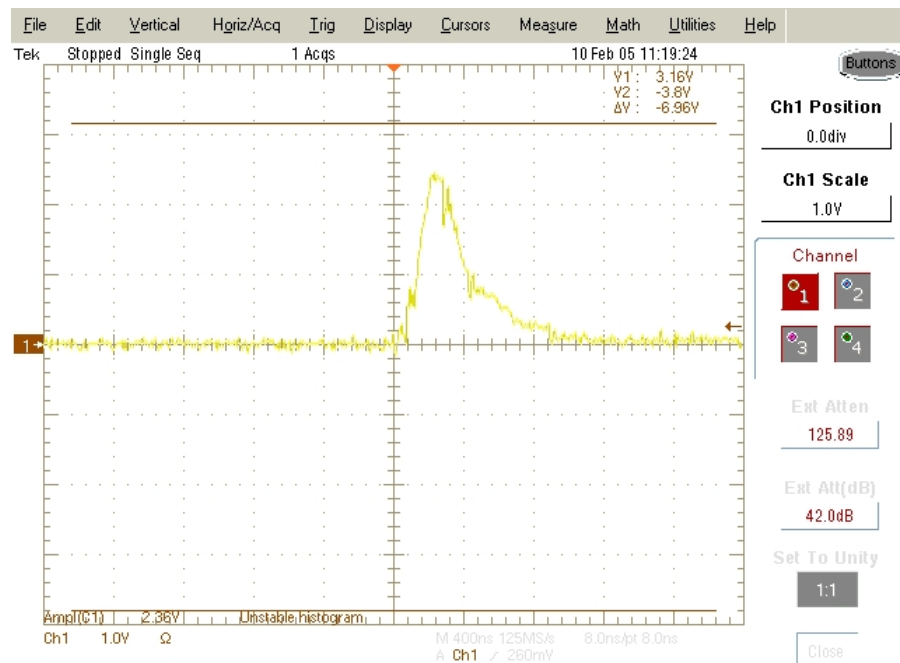
Fig. 44 Initial voltage response (2.4 V peak)

The test sample as tested met the requirements as specified (see Figs. 44 through 49 below).

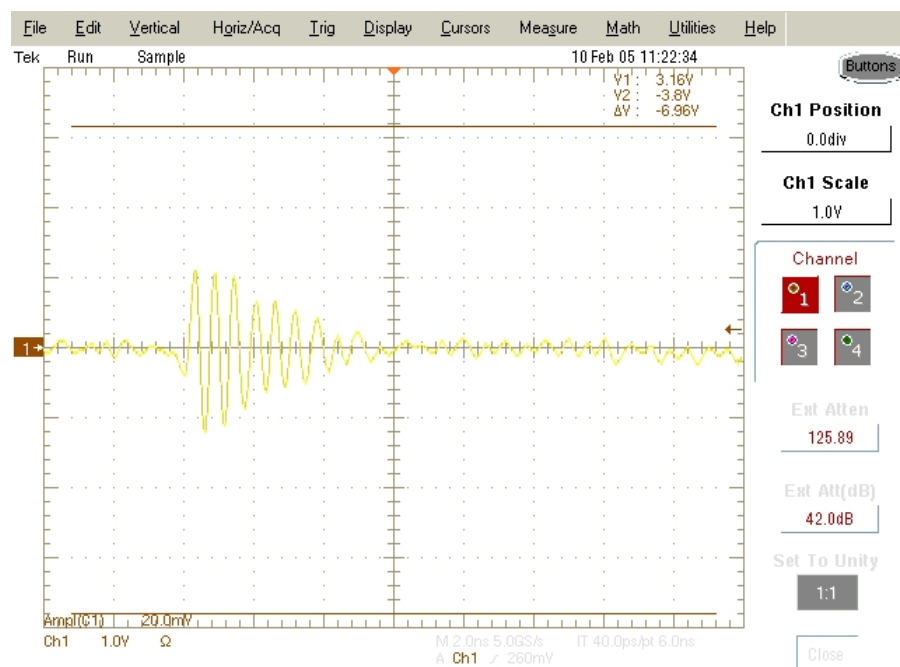
Fig. 45 Initial voltage response (1 V peak)

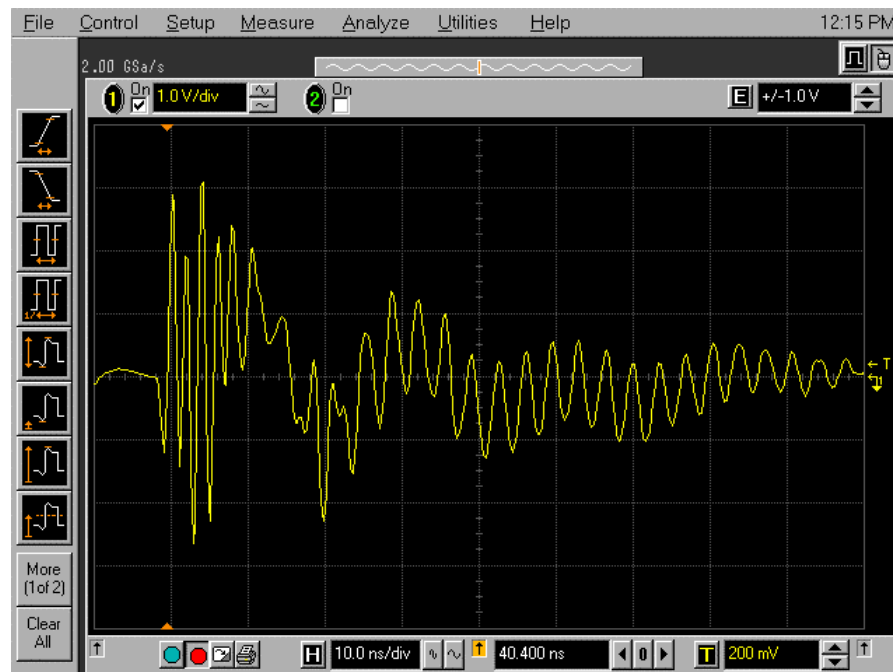
Fig. 46 Voltage response after 200 durability cycles (2.5 V peak)

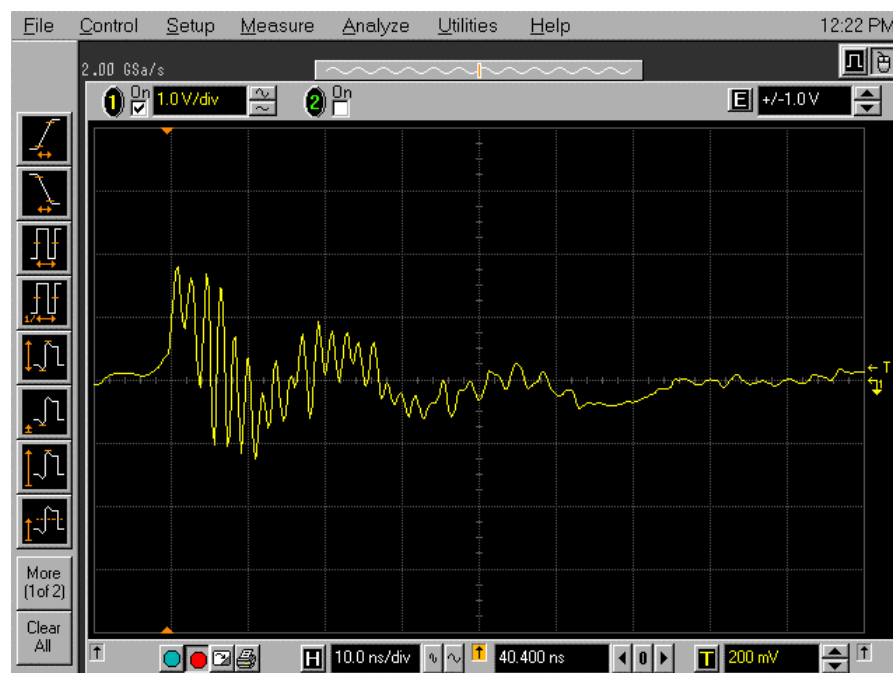
Fig. 47 Voltage response after 200 durability cycles (1.8 V peak)

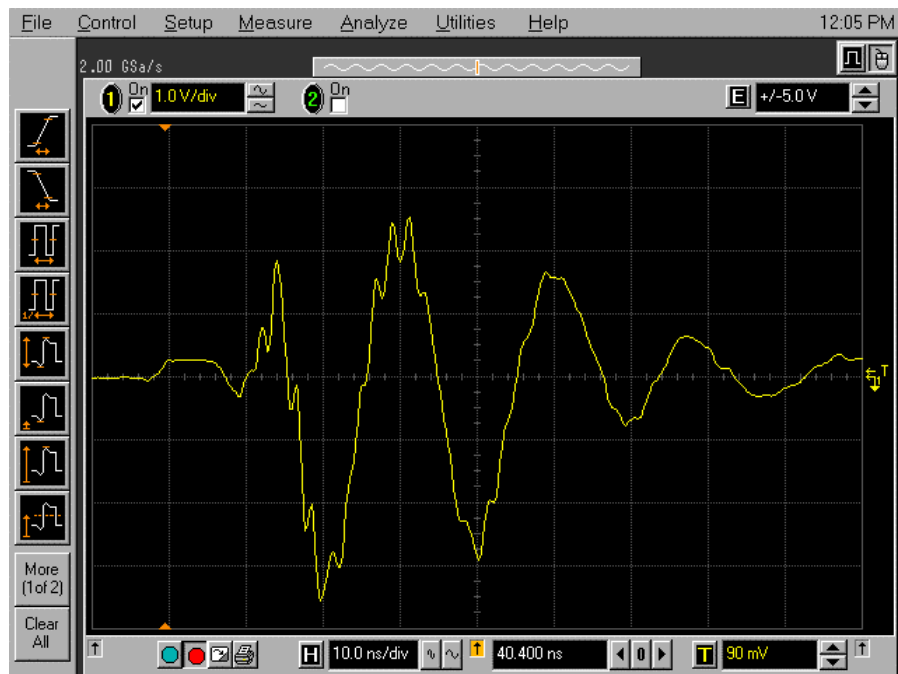
Fig. 48 Voltage response after 500 durability cycles (3.4 V peak)

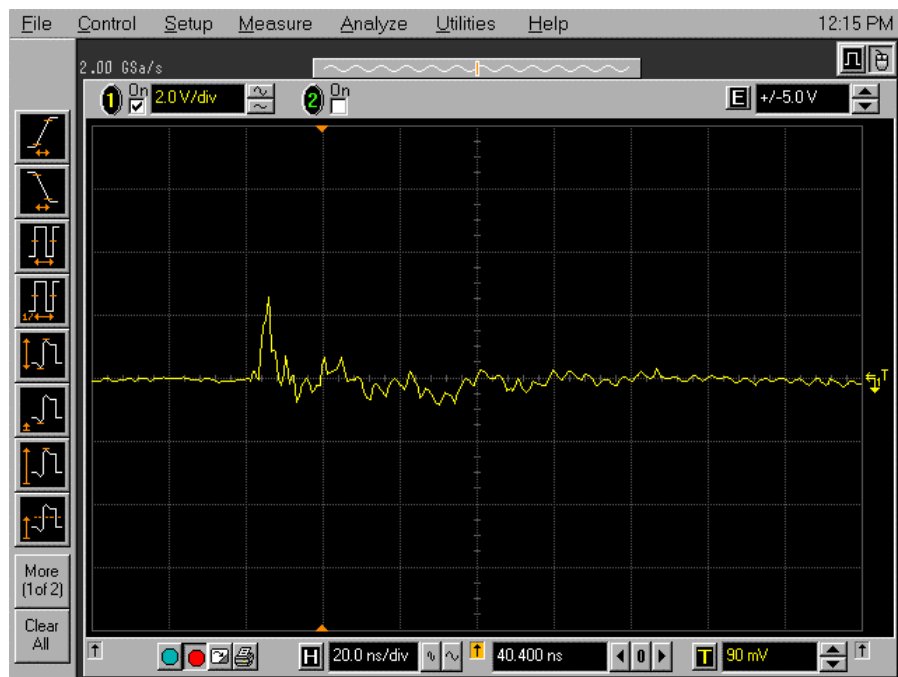
Fig. 49 Voltage response after 500 durability cycles (2.5 V peak)
