Vita 72 VPX Connector Update for Open Standard Module Vibration Reliability Testing

September 19, 2012 Rev 1.1

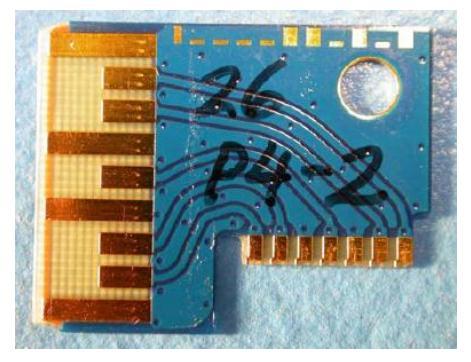
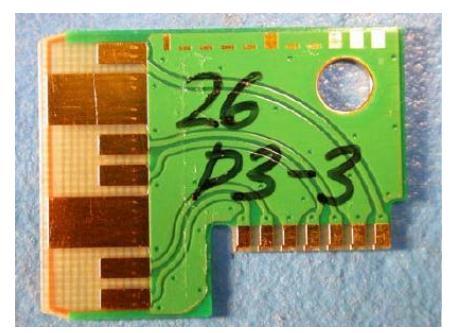
Evidence of fretting corrosion from original VITA tests

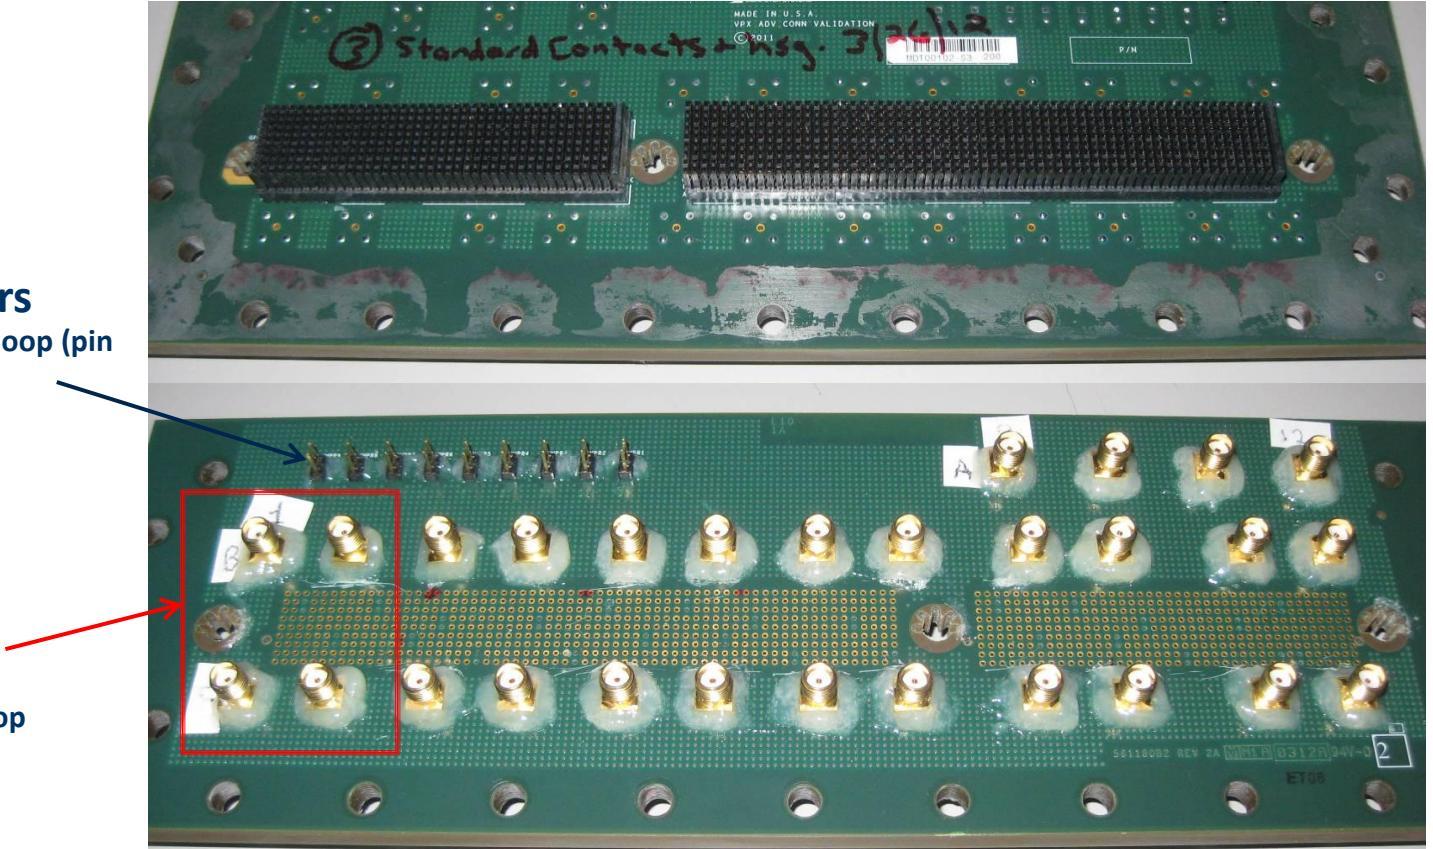
Test Backplane Design Overview

- Supports 7 differential pair signals
- 0.250 inch thick, 30 layer PCB
 - 1st Resonance @ 944 Hz (Analysis)

LLCR Headers 1 Header is a complete loop (pin 1 to pin 2)

SMA conns 4 SMAs complete 1 differential pair loop

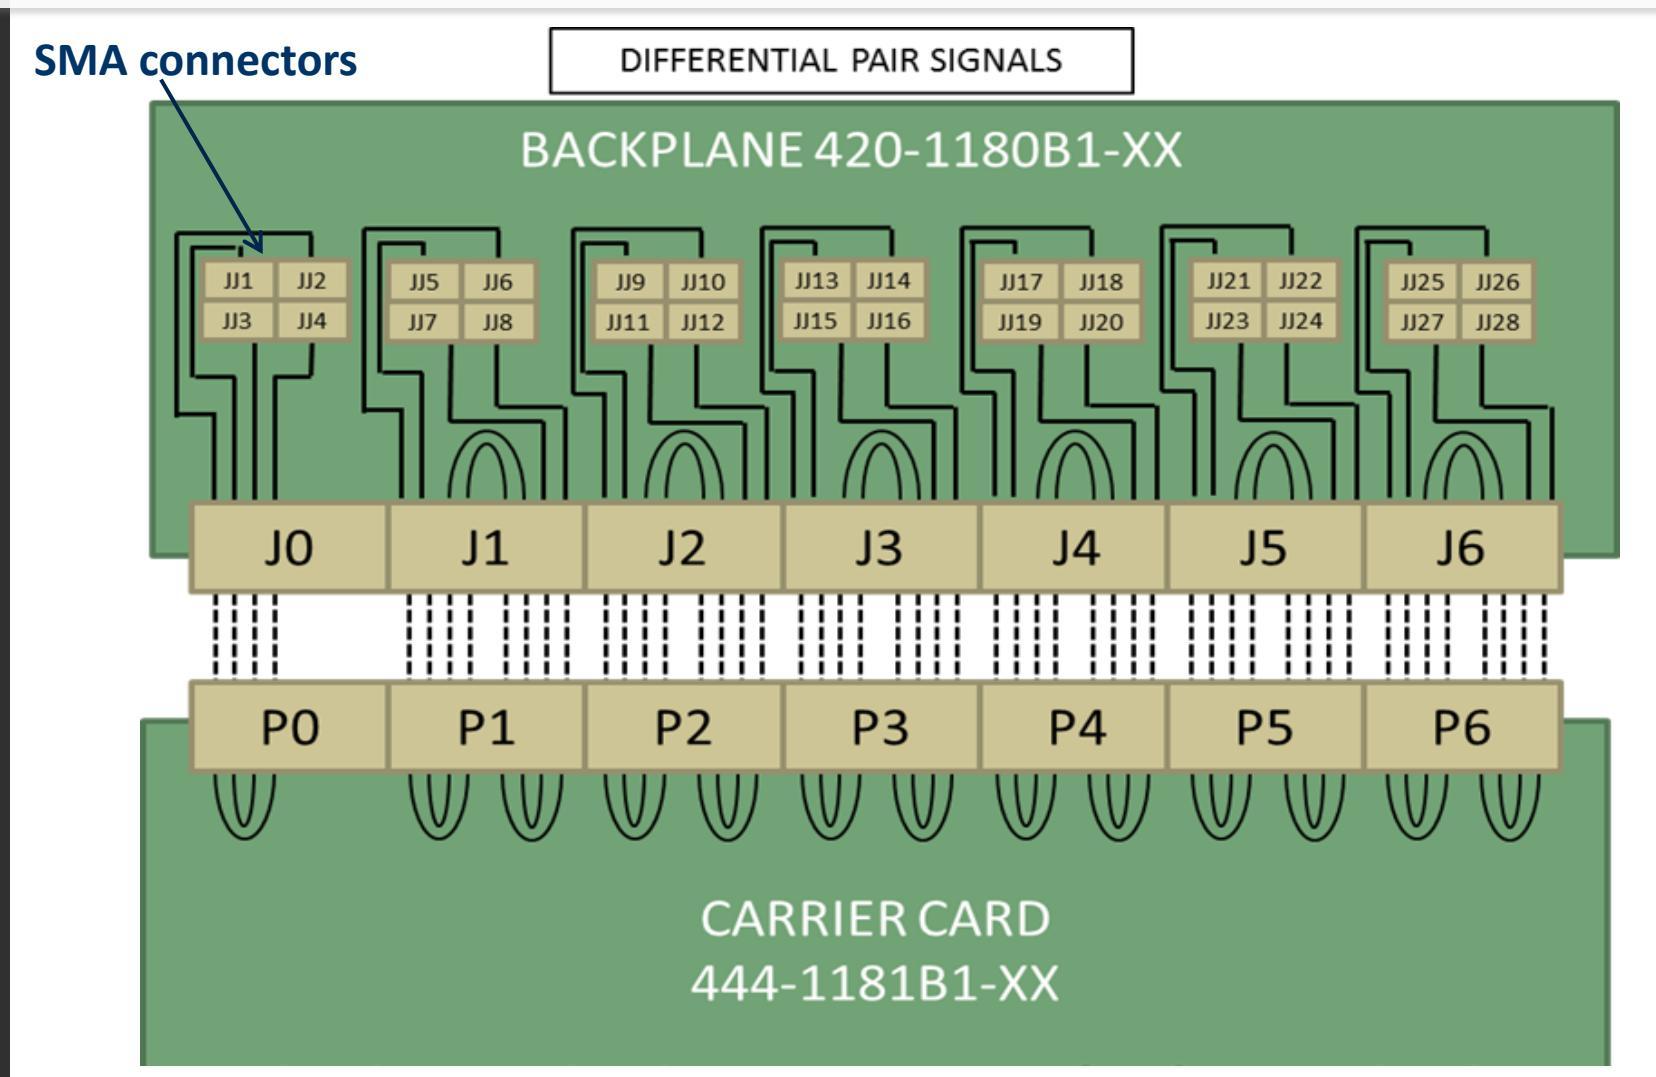
Schematic Interconnect Block Diagram

Hi-speed signal traces

All signals loop back through the payload/carrier card

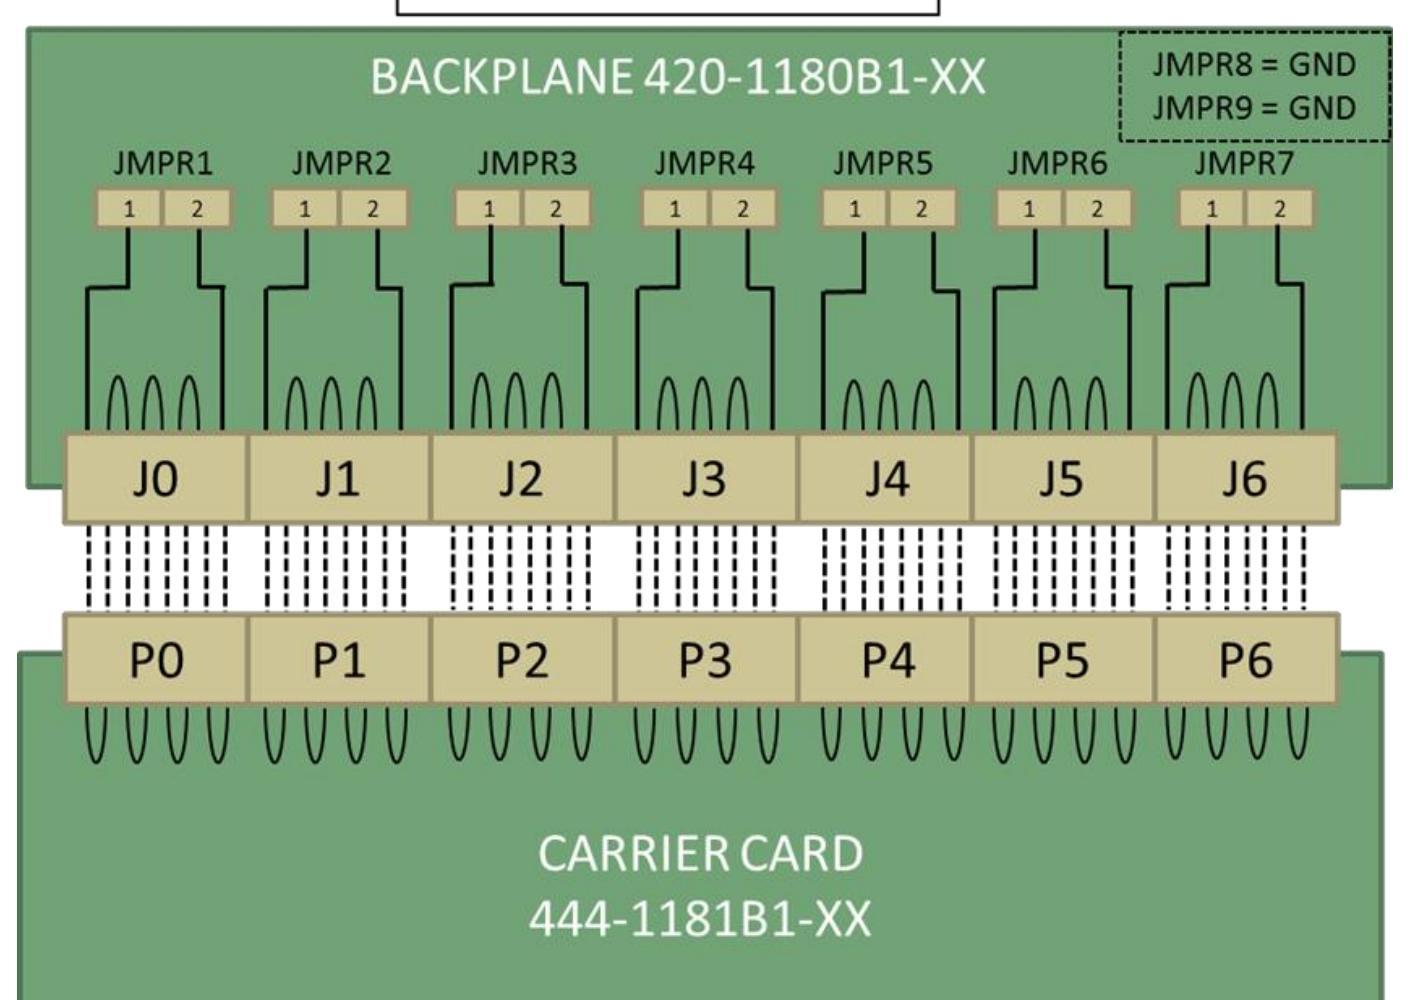
Schematic Interconnect Block Diagram

SINGLE ENDED SIGNALS

All signals loop back through the payload/carrier card

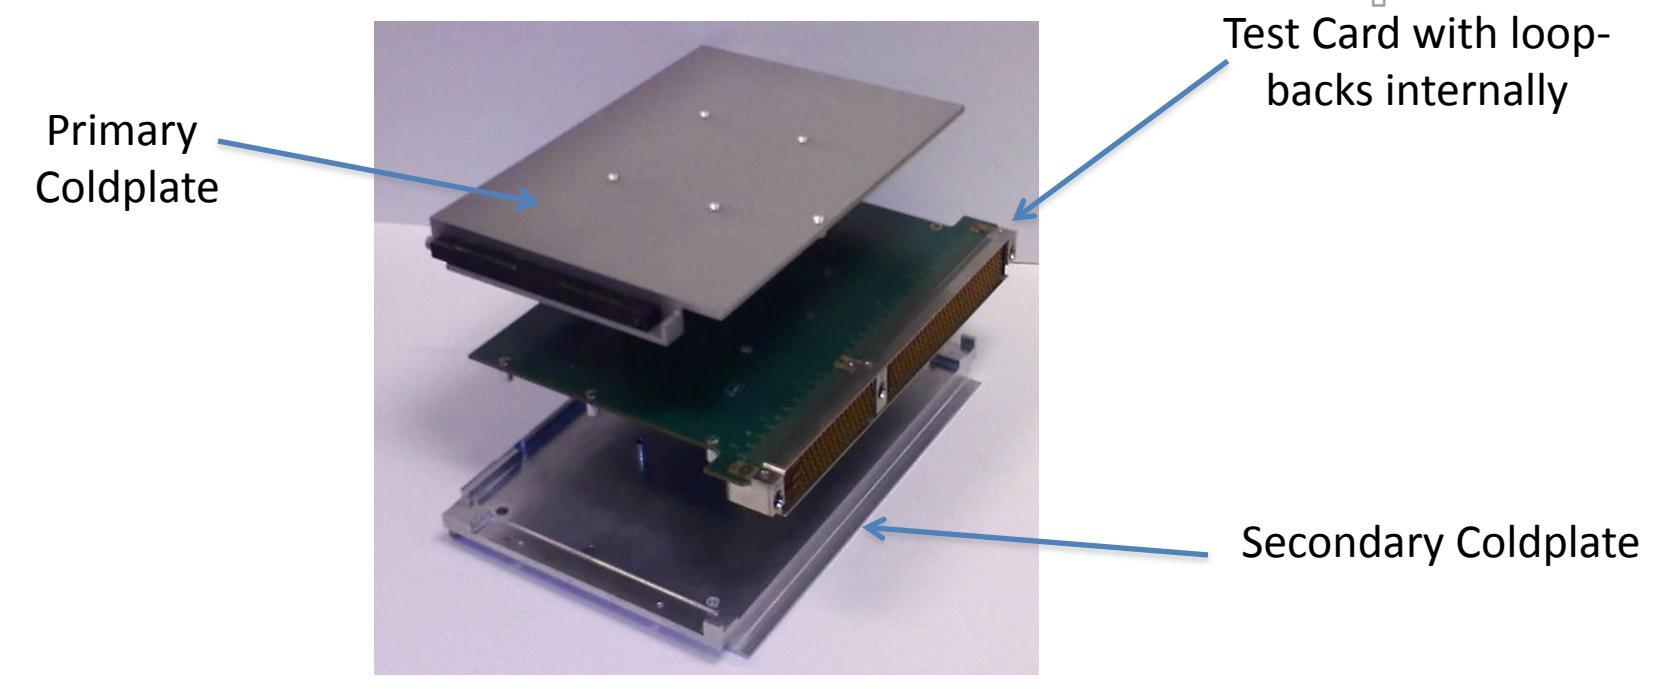
Test Configuration for VITA 48.2 VPX C/C Test

Viper, Tyco and Tyco Extreme Coldplate complete with wedgelocks and hardware: 3.08 lb (1.395 kg)		
Coldplate complete with wedgelocks and hardware: 3.08 lb (1.395 kg)		
Bare board: 0.22 lb (0.100 kg)		
Viper connector P/N: 400-1058-02 Weight: 0.43 lb (0.195 kg)		
Tyco connector P/N: 400-1058-01 Weight: 0.143 lb (0.065kg)		
Tyco Extreme connector P/N: 400-1058-03 Weight: 0.37 lb (0.168 kg)		
USB port to communicate with laptop computer.		
Used to program and run the BER device and monitor the UUT through the USB ports.		
Altera Statix IV v9.0.; Mercury Signal integrity test software

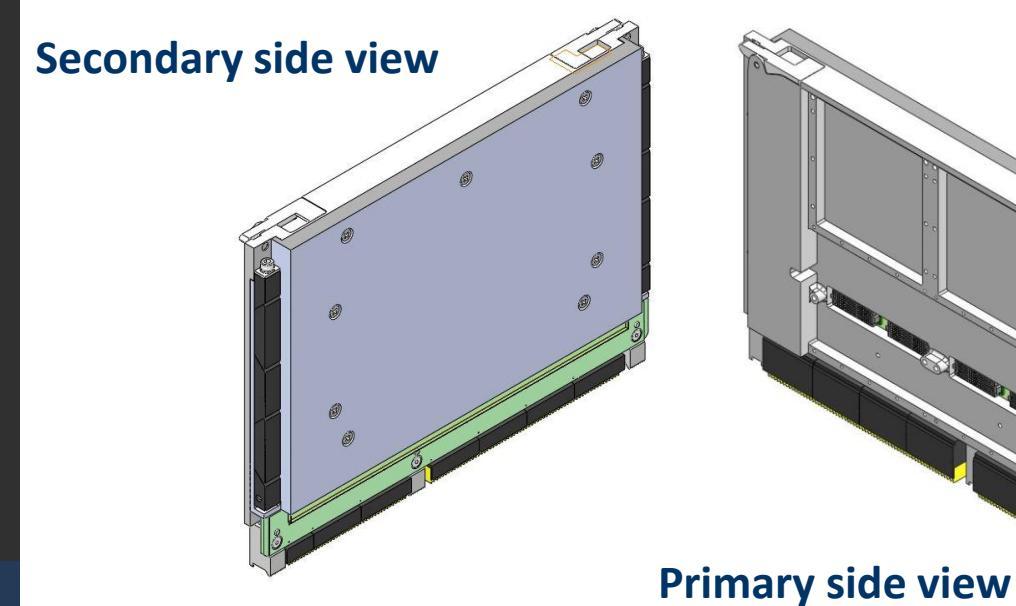
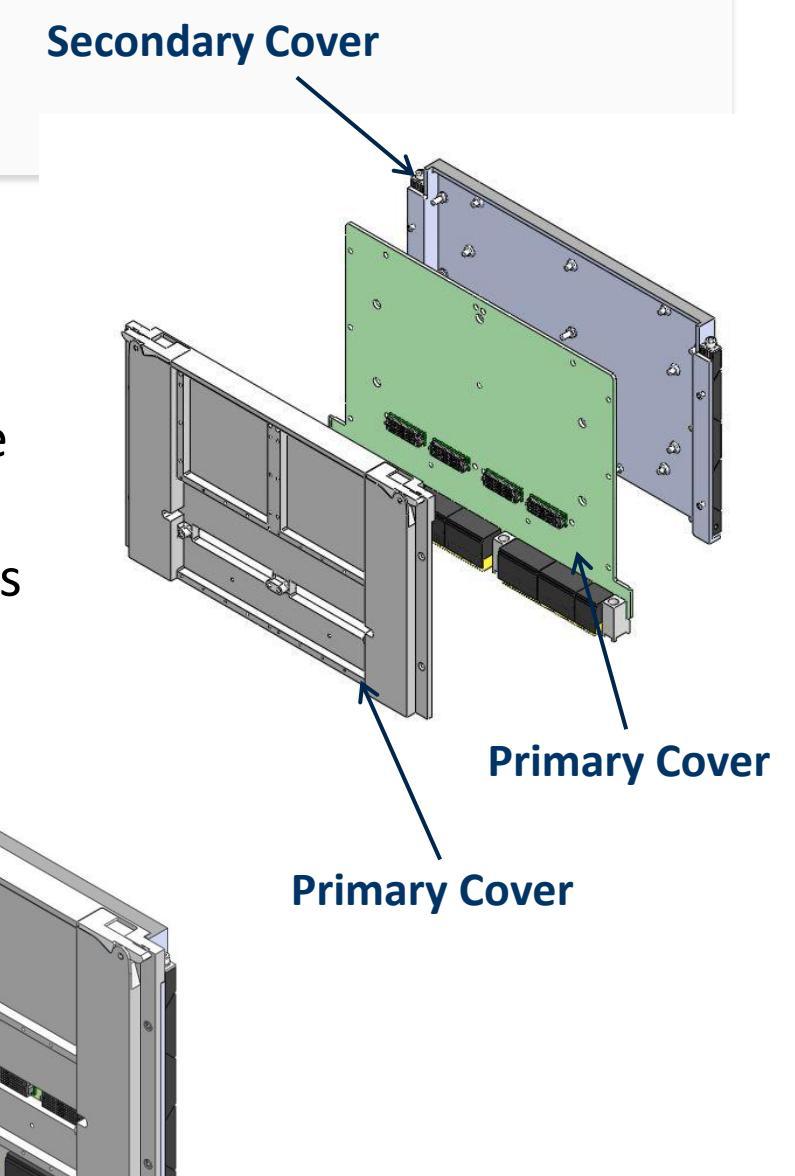
6U CARRIER & COLDPLATES

- Conforms to VITA 48.2
 - Uses secondary side wedgelocks
- Simplified packaging that mimics standard conduction cooled module design
- Carrier card supports two XMC cards – centered

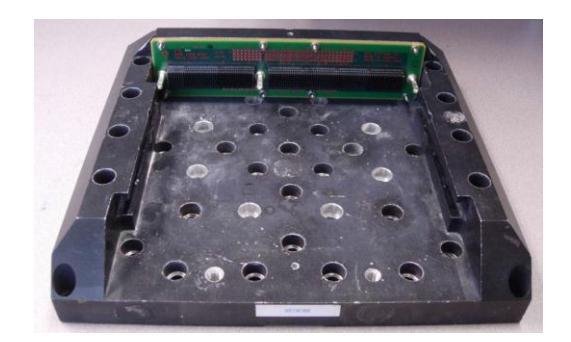
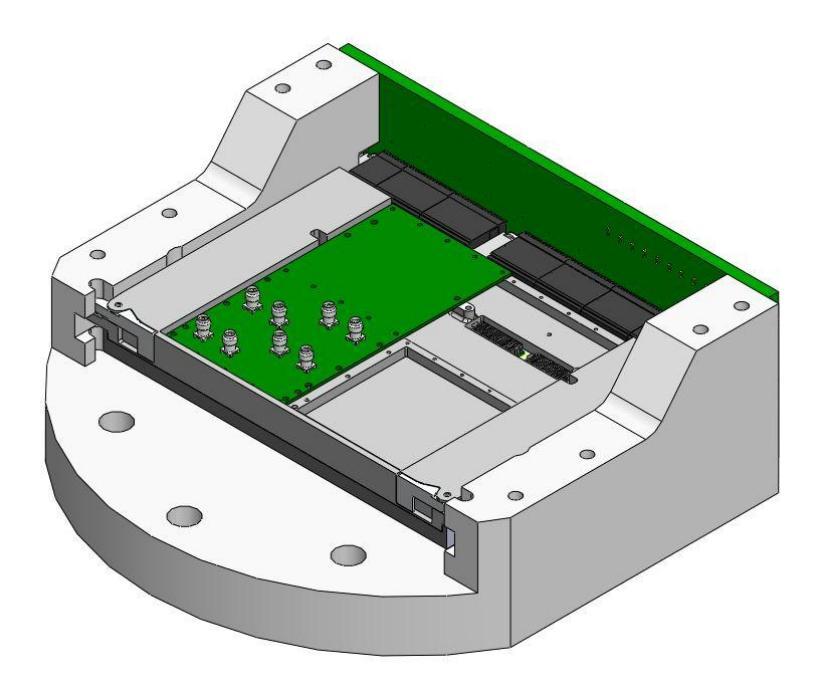
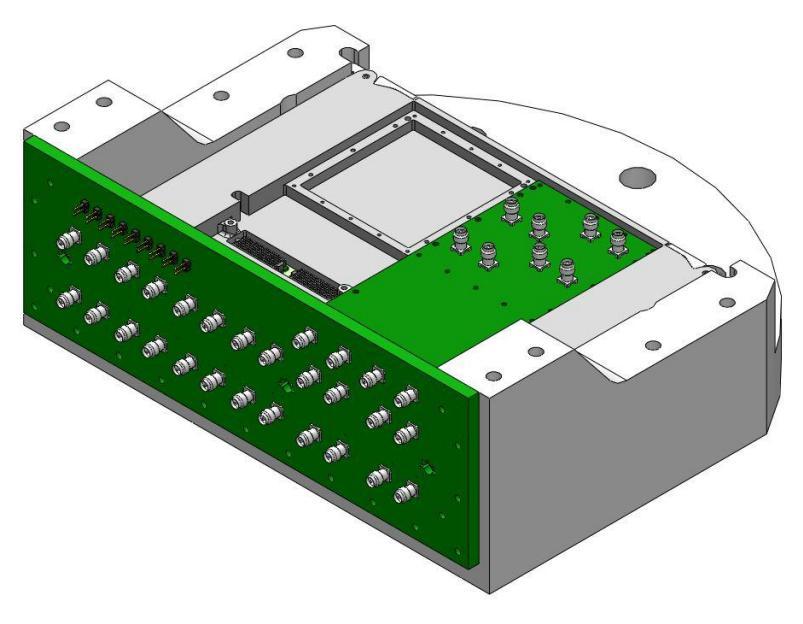
Vibration Test Fixture Assembly

Design leveraged from previous VITA 46 testing

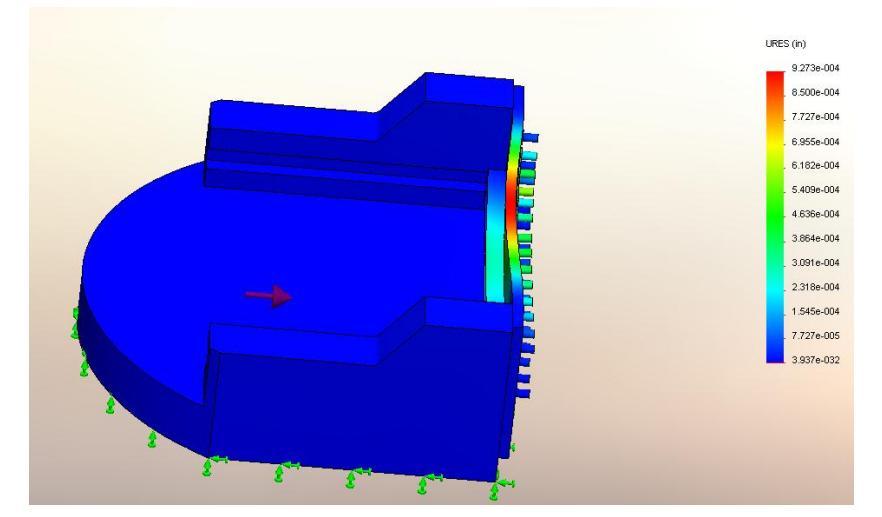
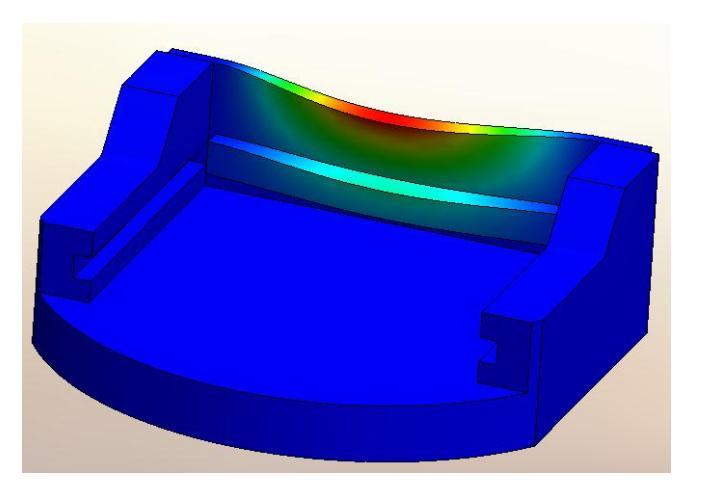
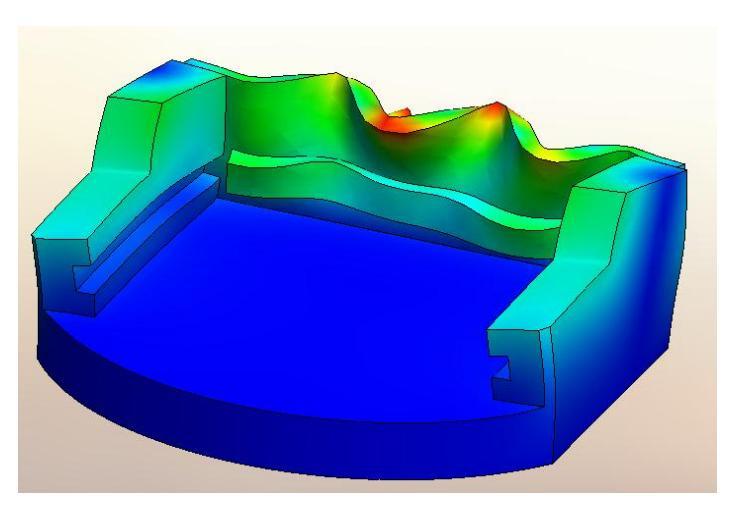
Vibration Fixture FEA Analysis

- Machined from solid block of aluminum
 - 6061-T6
- Calculated Fixture 1st mode resonance of Fixture @ 6225Hz

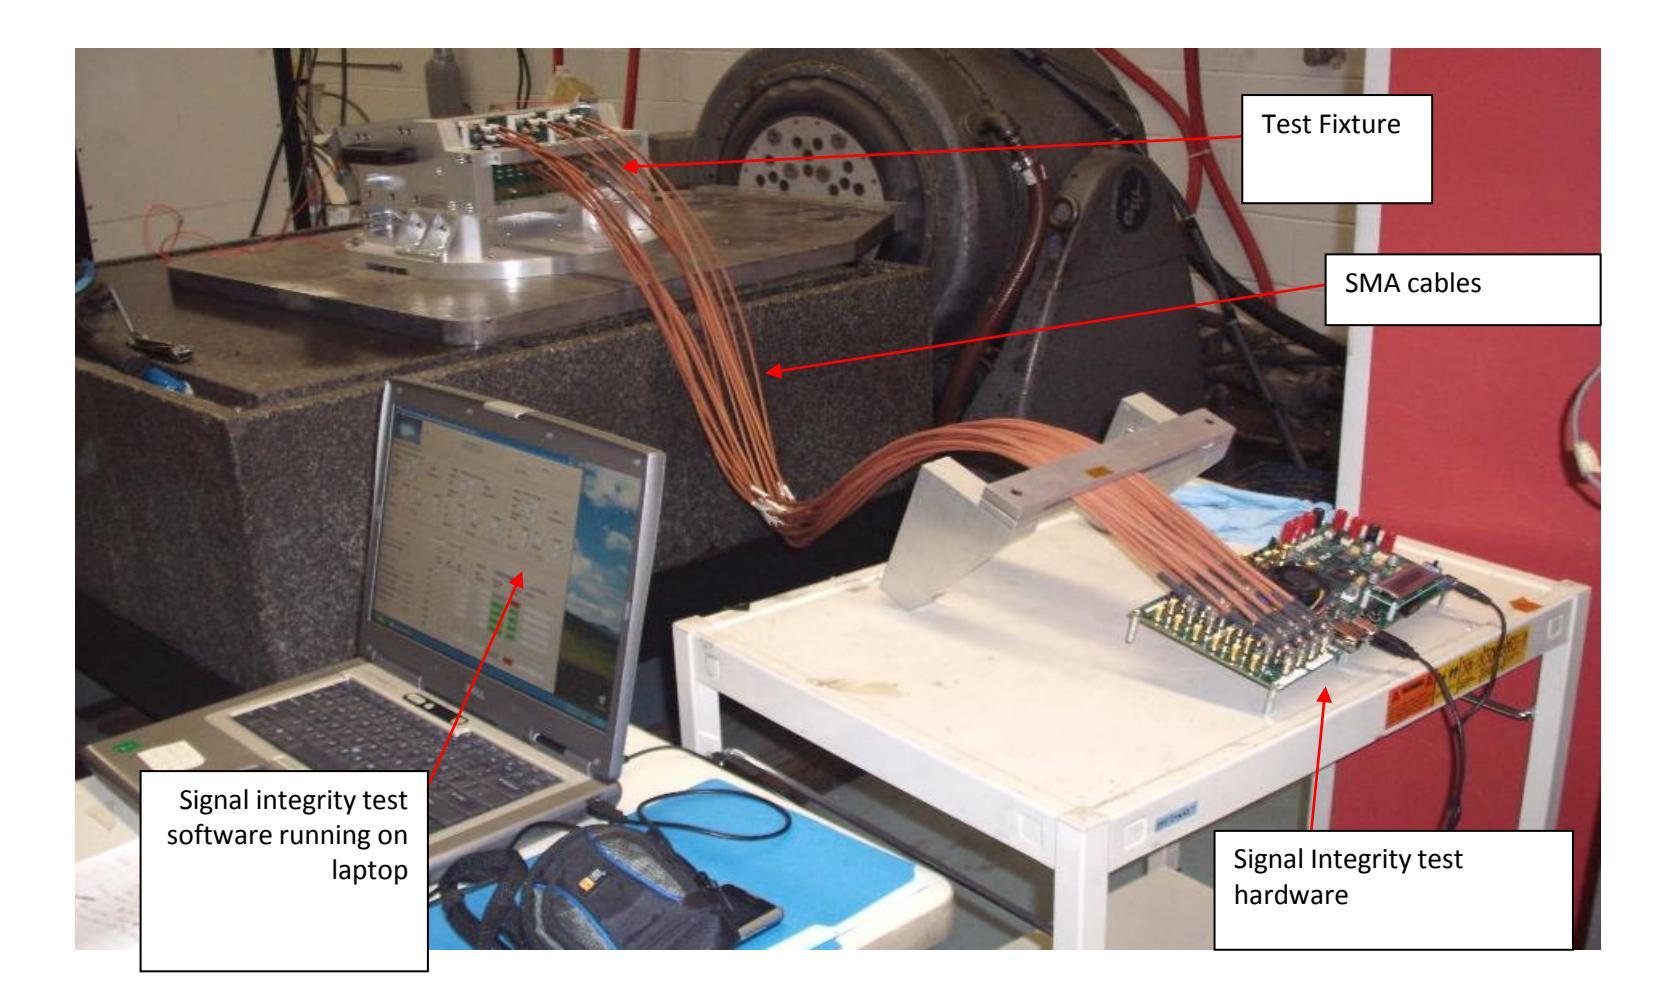
Mercury VPX 3.125 G-Baud Signal Verification Test during "Rugged" Vibration

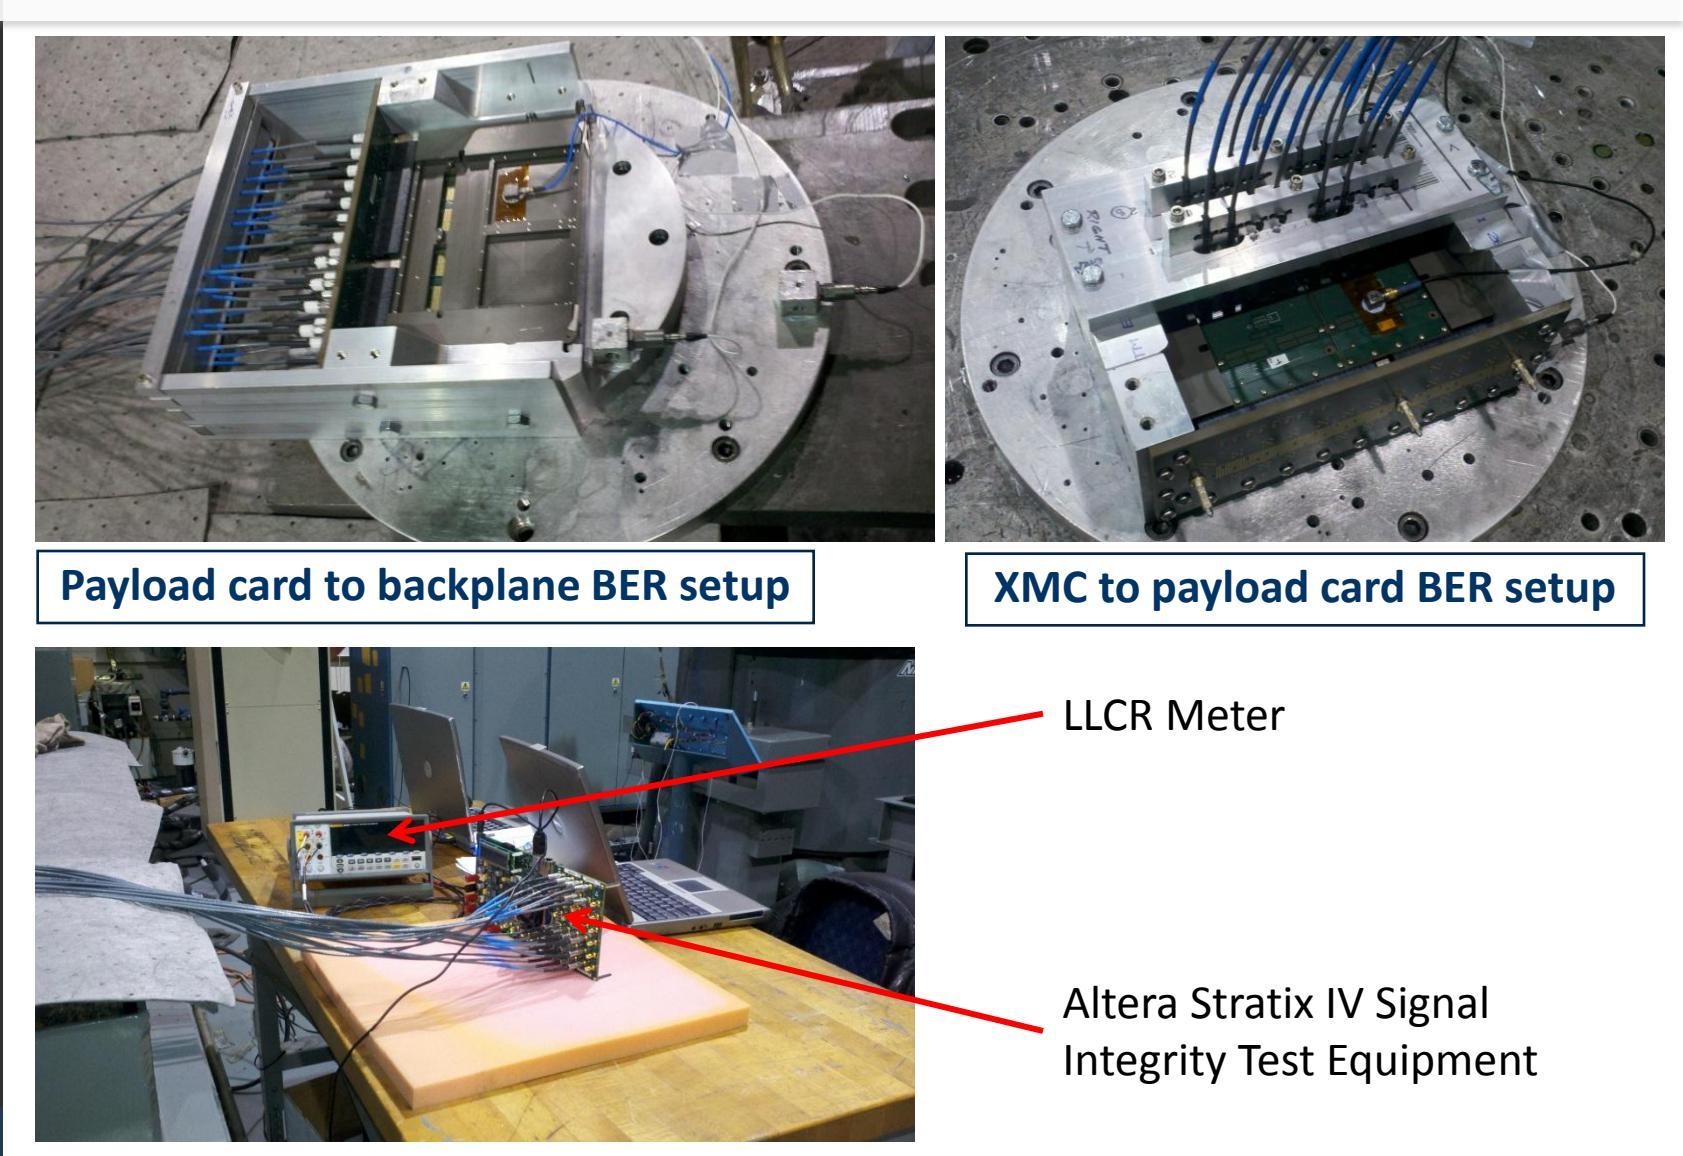
Extreme Vibration Test Setup

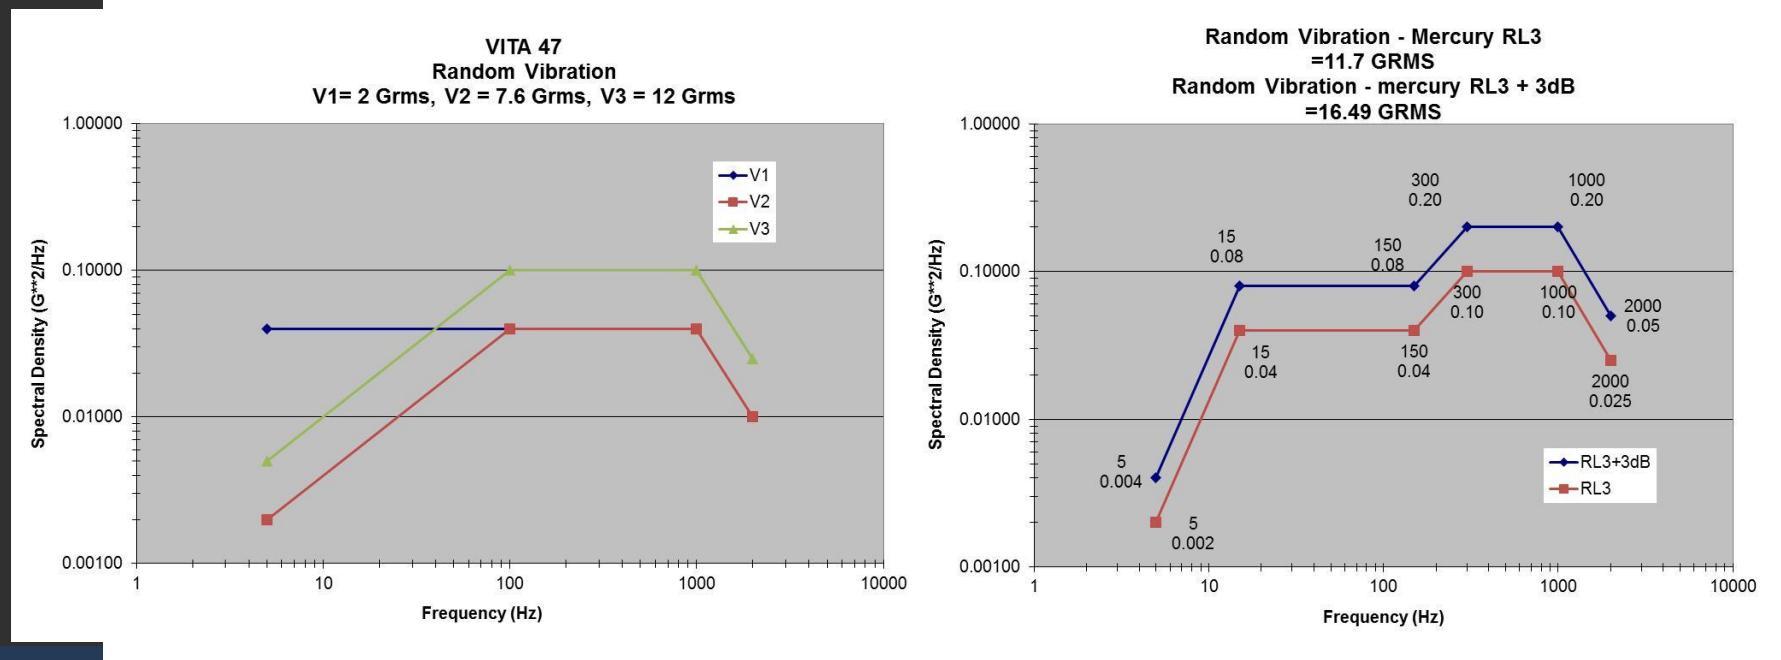
VPX Connector Vibration Profiles

- Tested per MIL-STD-810F, Method 514.5
- Extended Duration Random Vibration Testing will be conducted
 - 1 hour per orthogonal axis at Mercury RL3 standard profile
 - 1 hour per orthogonal axis at Mercury RL3 + 3dB standard profile
 - 12 hours, Z-axis only @ +3dB over Mercury RL3 standard profile
- Failure Analysis includes high resolution / SEMS photos of contact mating surfaces on all connectors for visual comparison

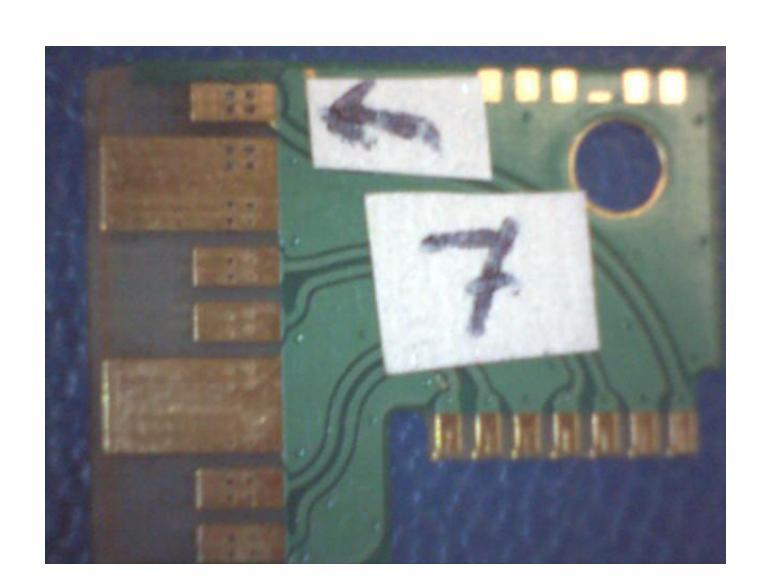
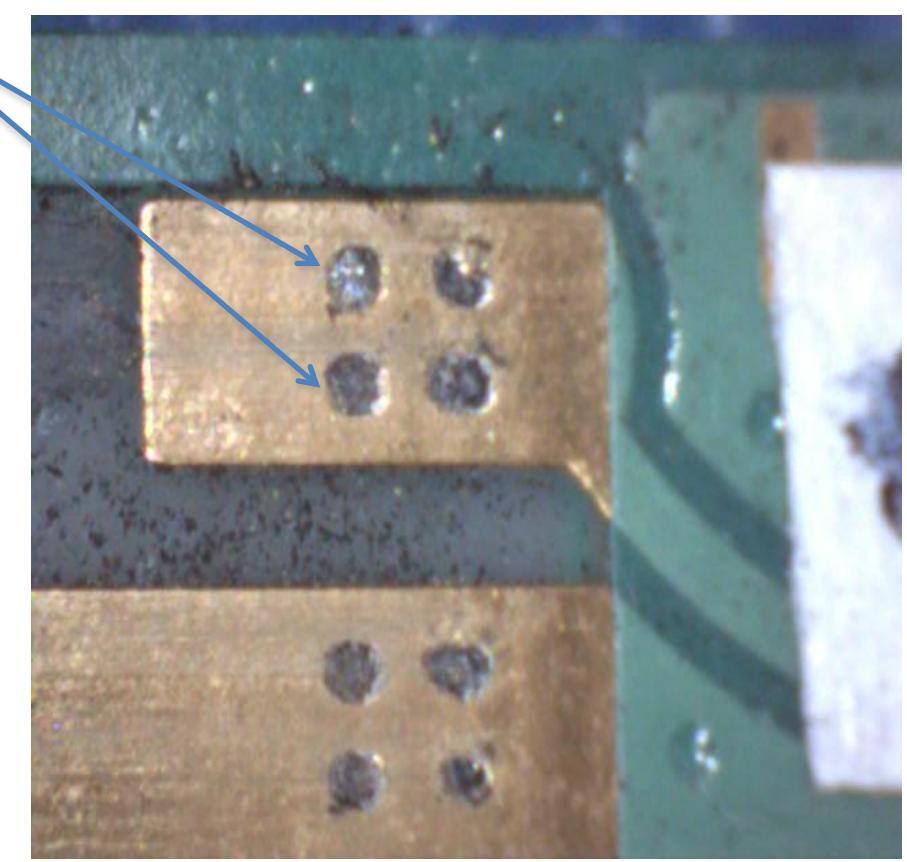
Extreme Fretting Corrosion & Contact Wear – RT2

Exposed PWB. Contacts wore through Gold, Nickel, & Copper pads on wafer

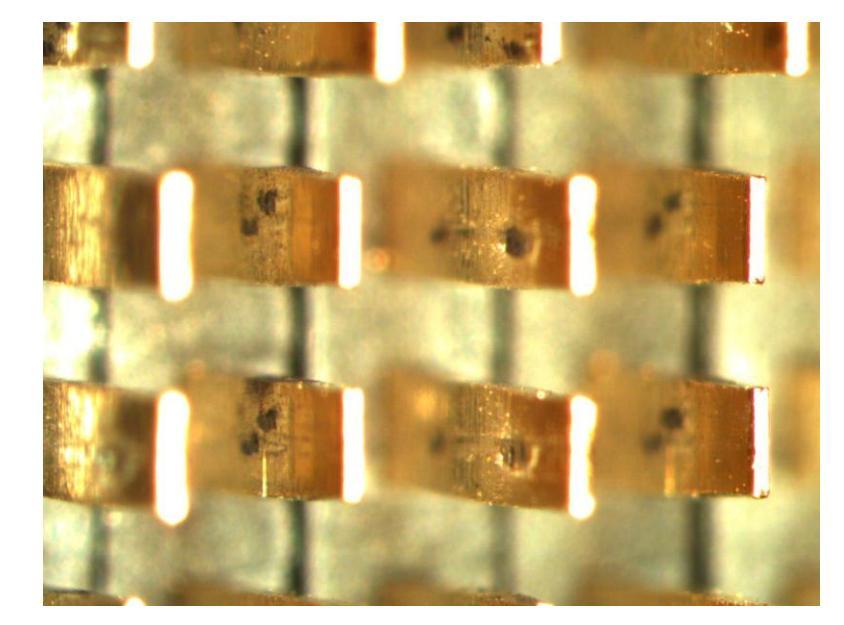
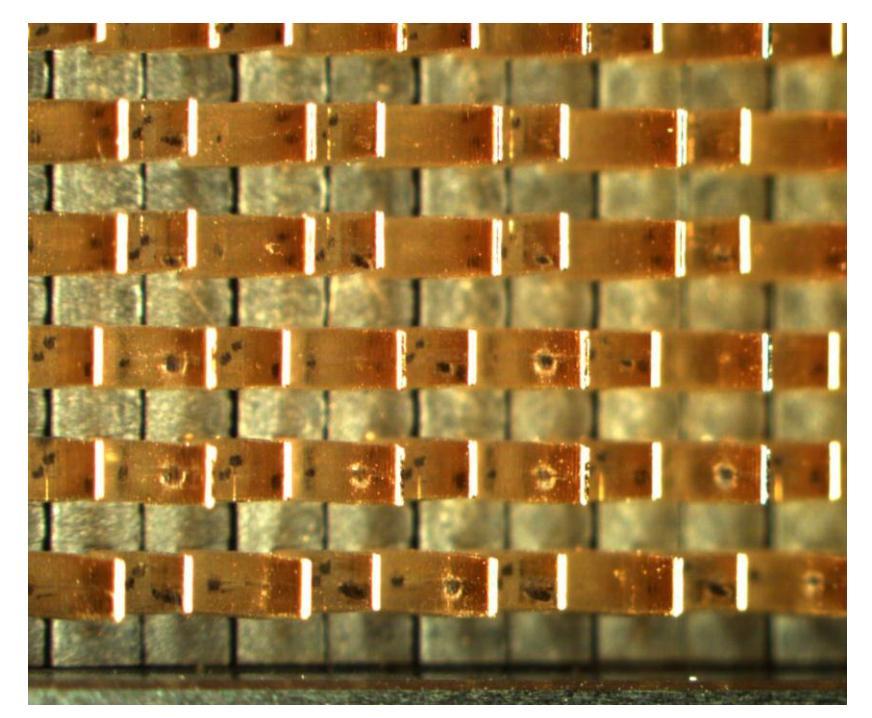
Vita 60 Viper Micro Action Fretting Corrosion

Viper had signs of fretting corrosion, but performed substantially better in the original Extreme Vibration Testing

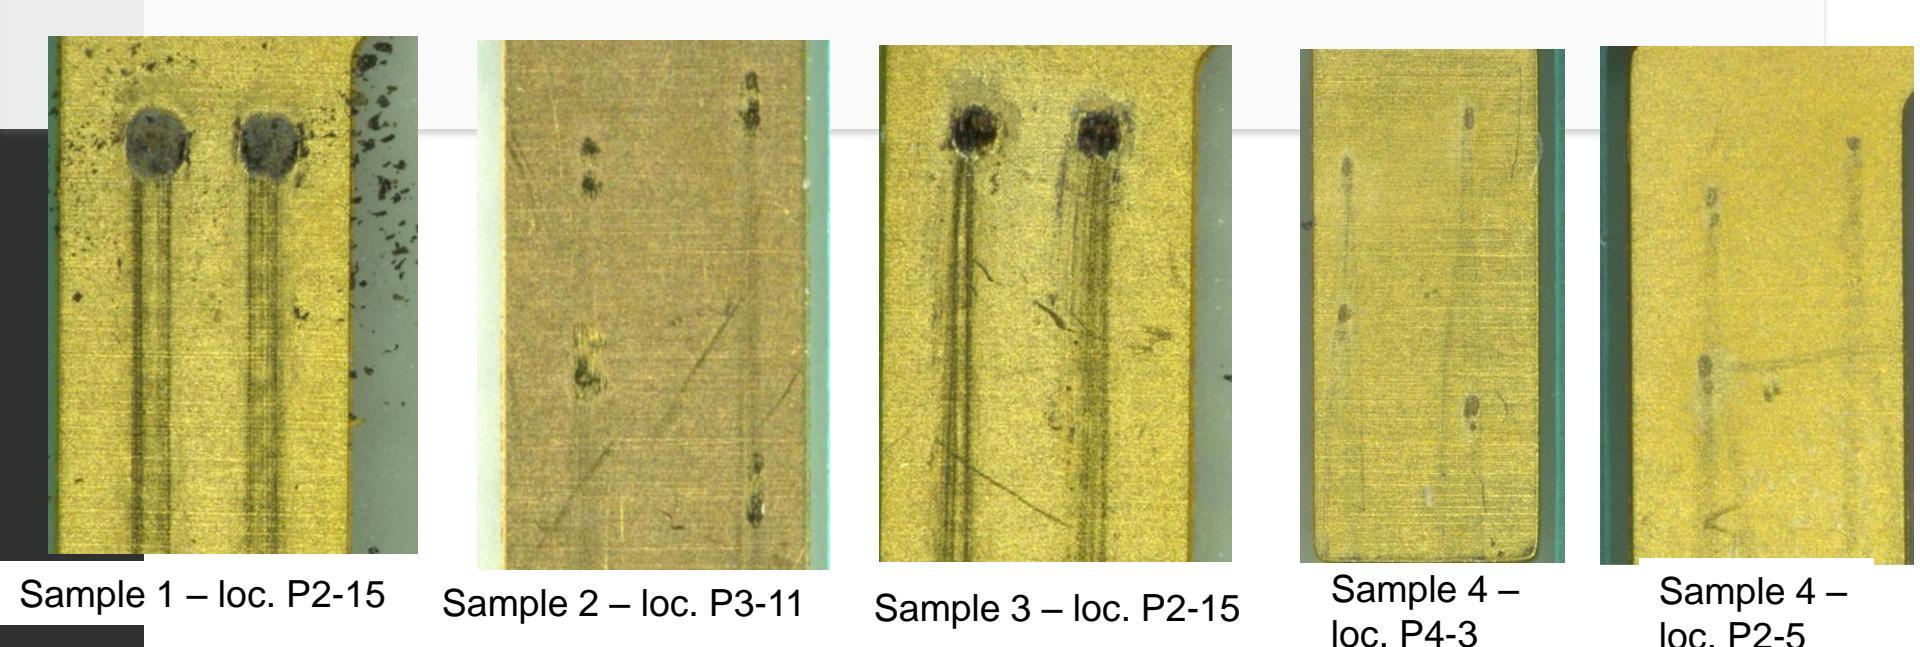
Comparison between worst wear spot from example samples

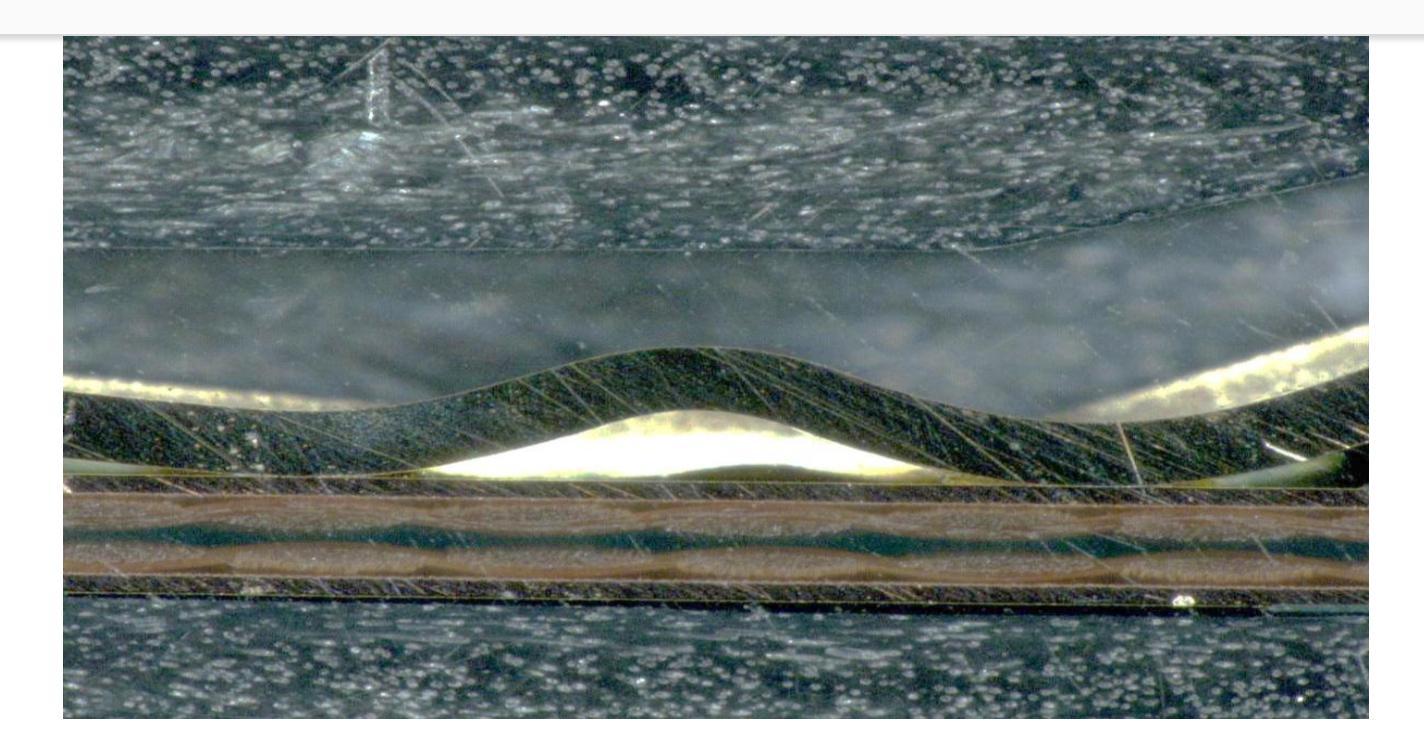
RT2-R Improved Contact Design

- 4 Points of connector contact
- Contacts have different insertion mode displacement to impact Backplane bowing

- Vita 46/48 RT2-R design provides:
 - Lower insertion force (~ 8%+ less insertion force)
 - Reduced Backplane Bowing
 - Increased Extreme Vibration Reliability
 - Performs at higher data rates (5 & 6.25 G-Baud) in rugged environments
 - Backwards/Forwards compatible with all existing VPX infrastructure
 - Intermatable
 - Intermountable
- Vita 46 46/48 60 63 Next Steps...
 - Execute Connector testing as they are available
 - Execute Test at PCIE 3.0 Data Rates (8 G-Baud)
 - Execute Test at 10KR Data Rates (10.3125 G-Baud)
 - Publish results under NDA's
